Yosemite Valley:

Hydrologic Regime, Soils, Pre-Settlement Vegetation, Disturbance, and Concepts for Restoration

David J. Cooper, Ph.D. and Evan C. Wolf, M.S.
Department of Forest, Rangeland and Watershed Stewardship
Colorado State University, Fort Collins, CO 80523

September 2008

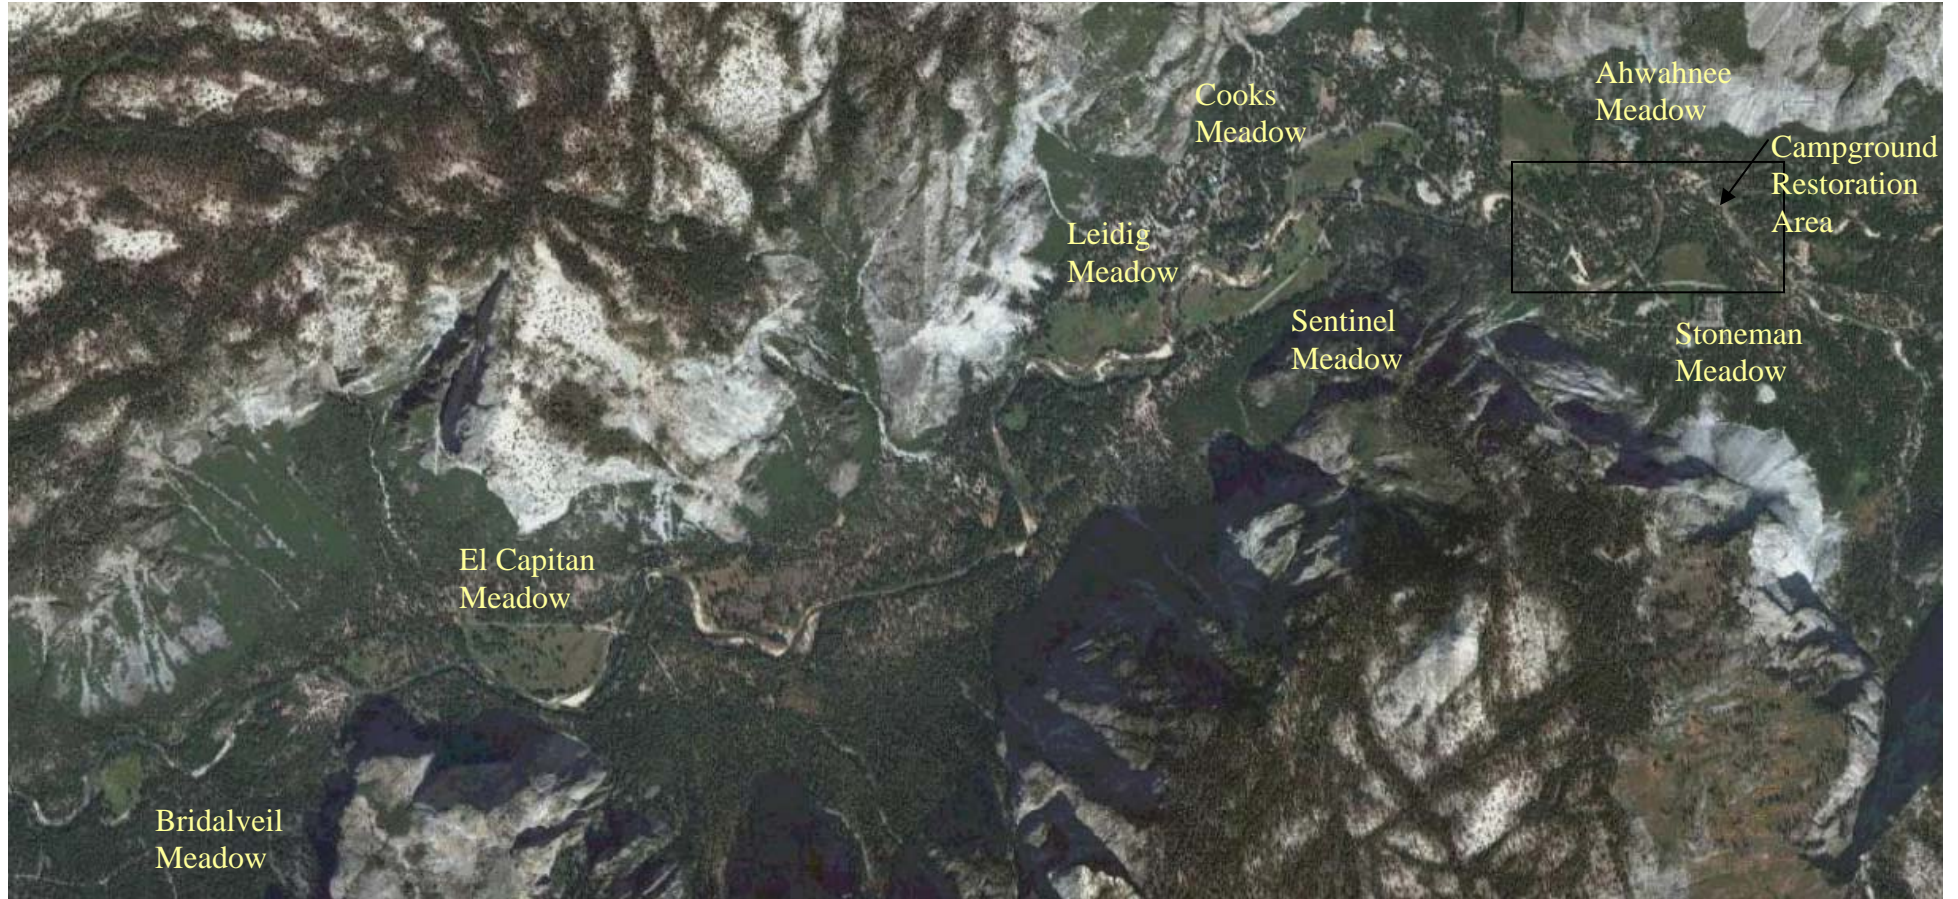
Figure 1. Aerial image of the Yosemite Valley study area. Reference meadows are identified, as well as the flooded campground restoration area.

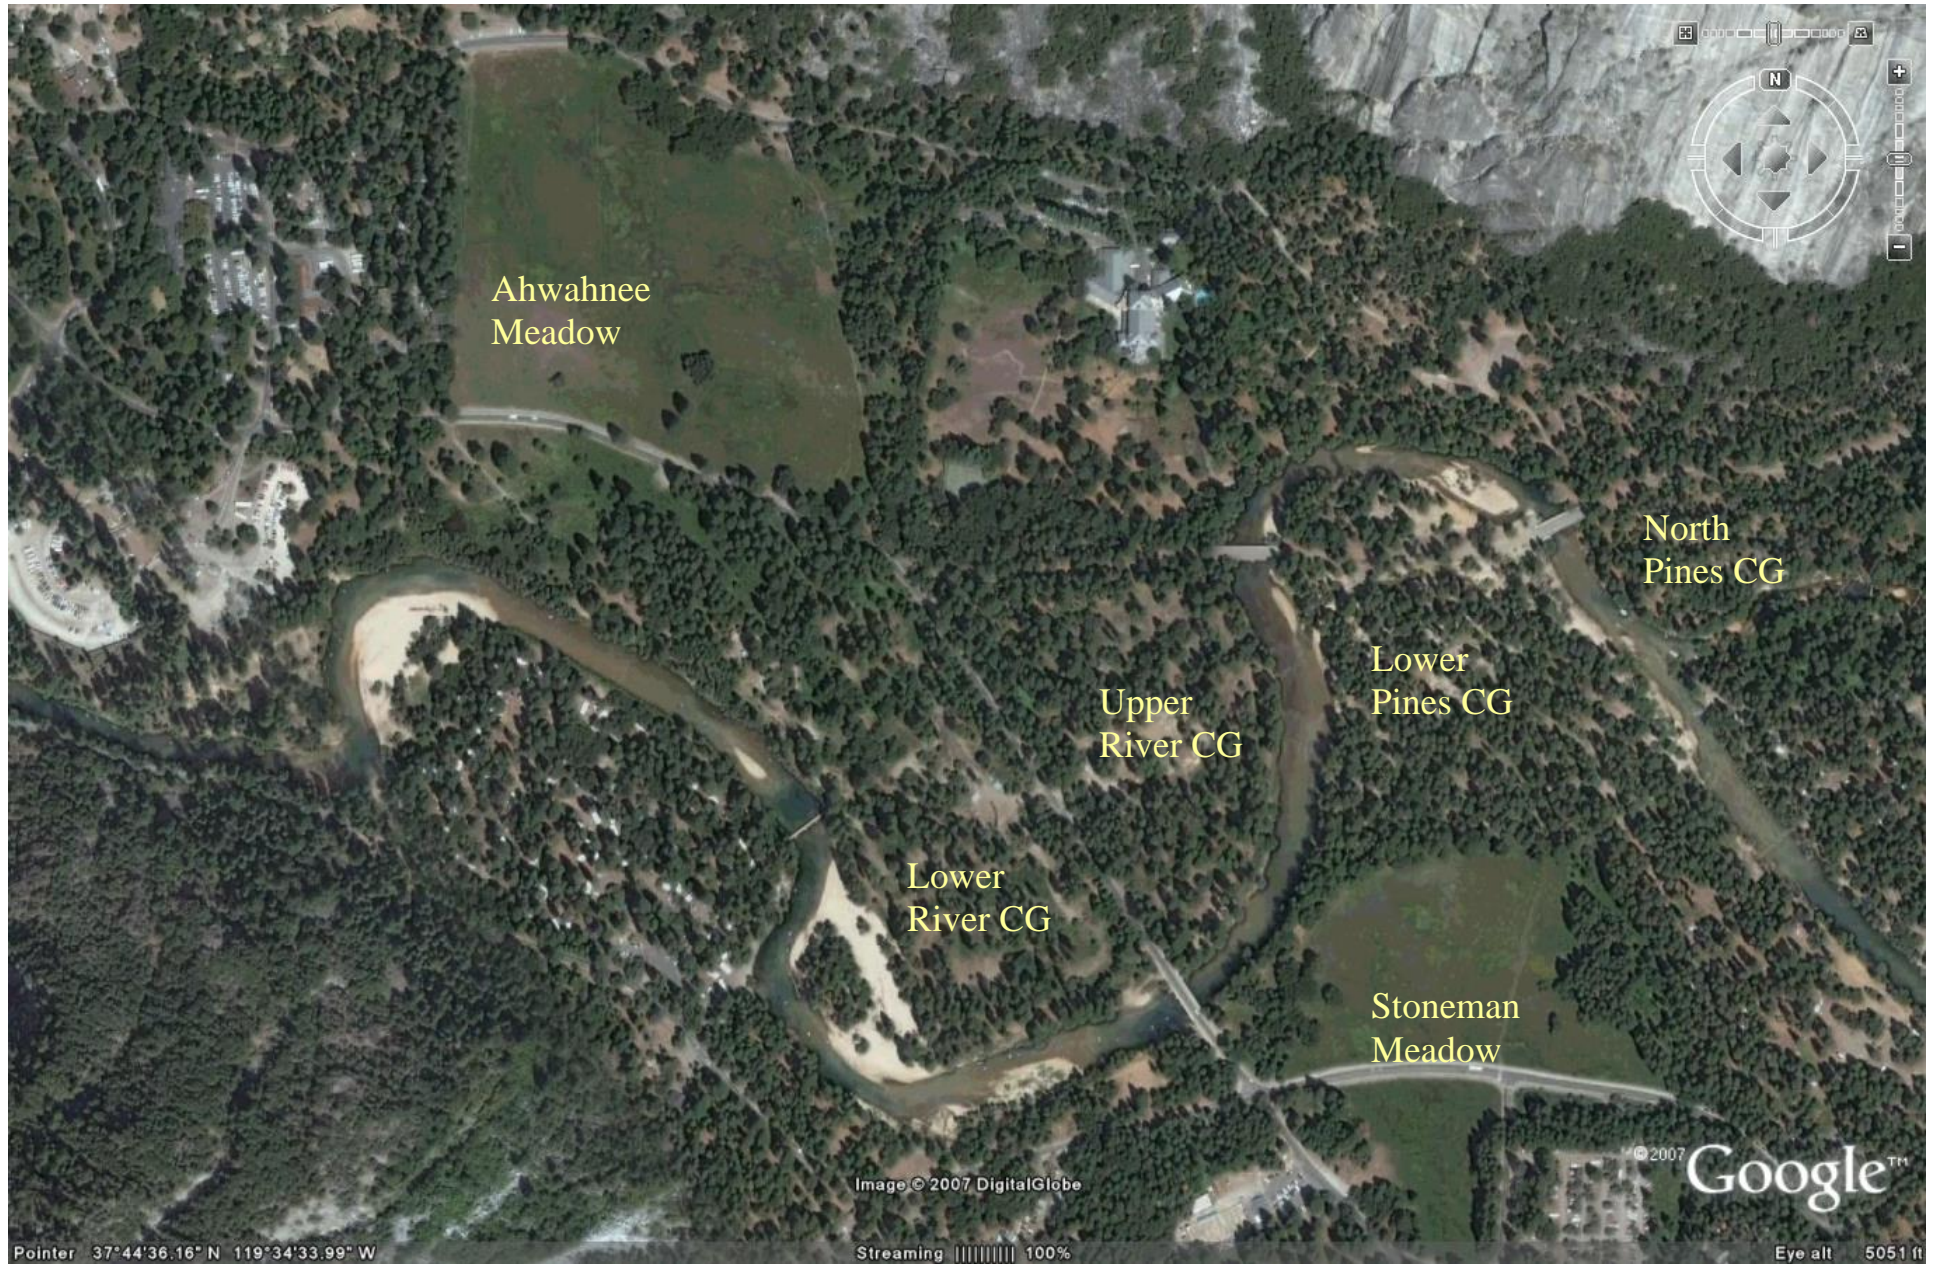
Figure 2. Aerial image of the campground study area. Shown are Ahwahnee Meadow (top center) and Stoneman Meadow (bottom right) and the Merced River.

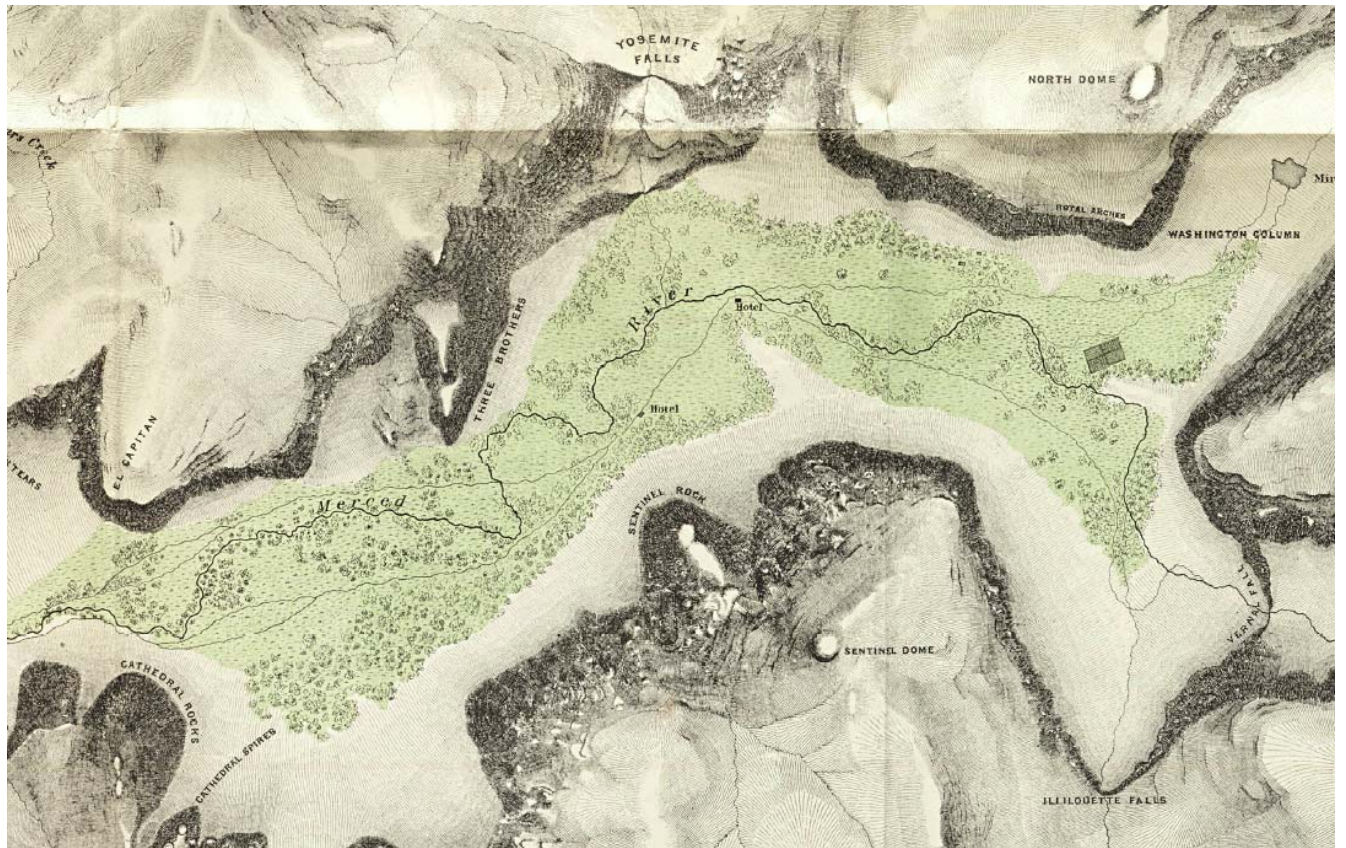
Figure 3. Map of Yosemite Valley by J. C. Whitney, 1868. This map shows the valley to be covered primarily by wet meadows and scattered *Quercus kelloggii* woodland on the valley margins.

Maps illustrating the characteristics of upper Yosemite Valley were created by Whitney (1868), Hoffmann (1867), and King and Gardner (1865) (Figures 3, 4 and 5) and all indicate that meadow and marsh complexes dominated the valley bottom. Trees, which likely are *Quercus kelloggii*, were abundant on the valley margins. In addition, scattered trees are drawn along the Merced River corridor, and likely are *Populus trichocarpa* (black cottonwood) and/or *Salix* spp. (willows) with scattered *Quercus* and likely some *Pinus ponderosa*. The maps clearly illustrate the broad extent of herbaceous dominated vegetation, and the marsh symbols on the Whitney and King and Gardner maps indicate that wetland conditions occurred.

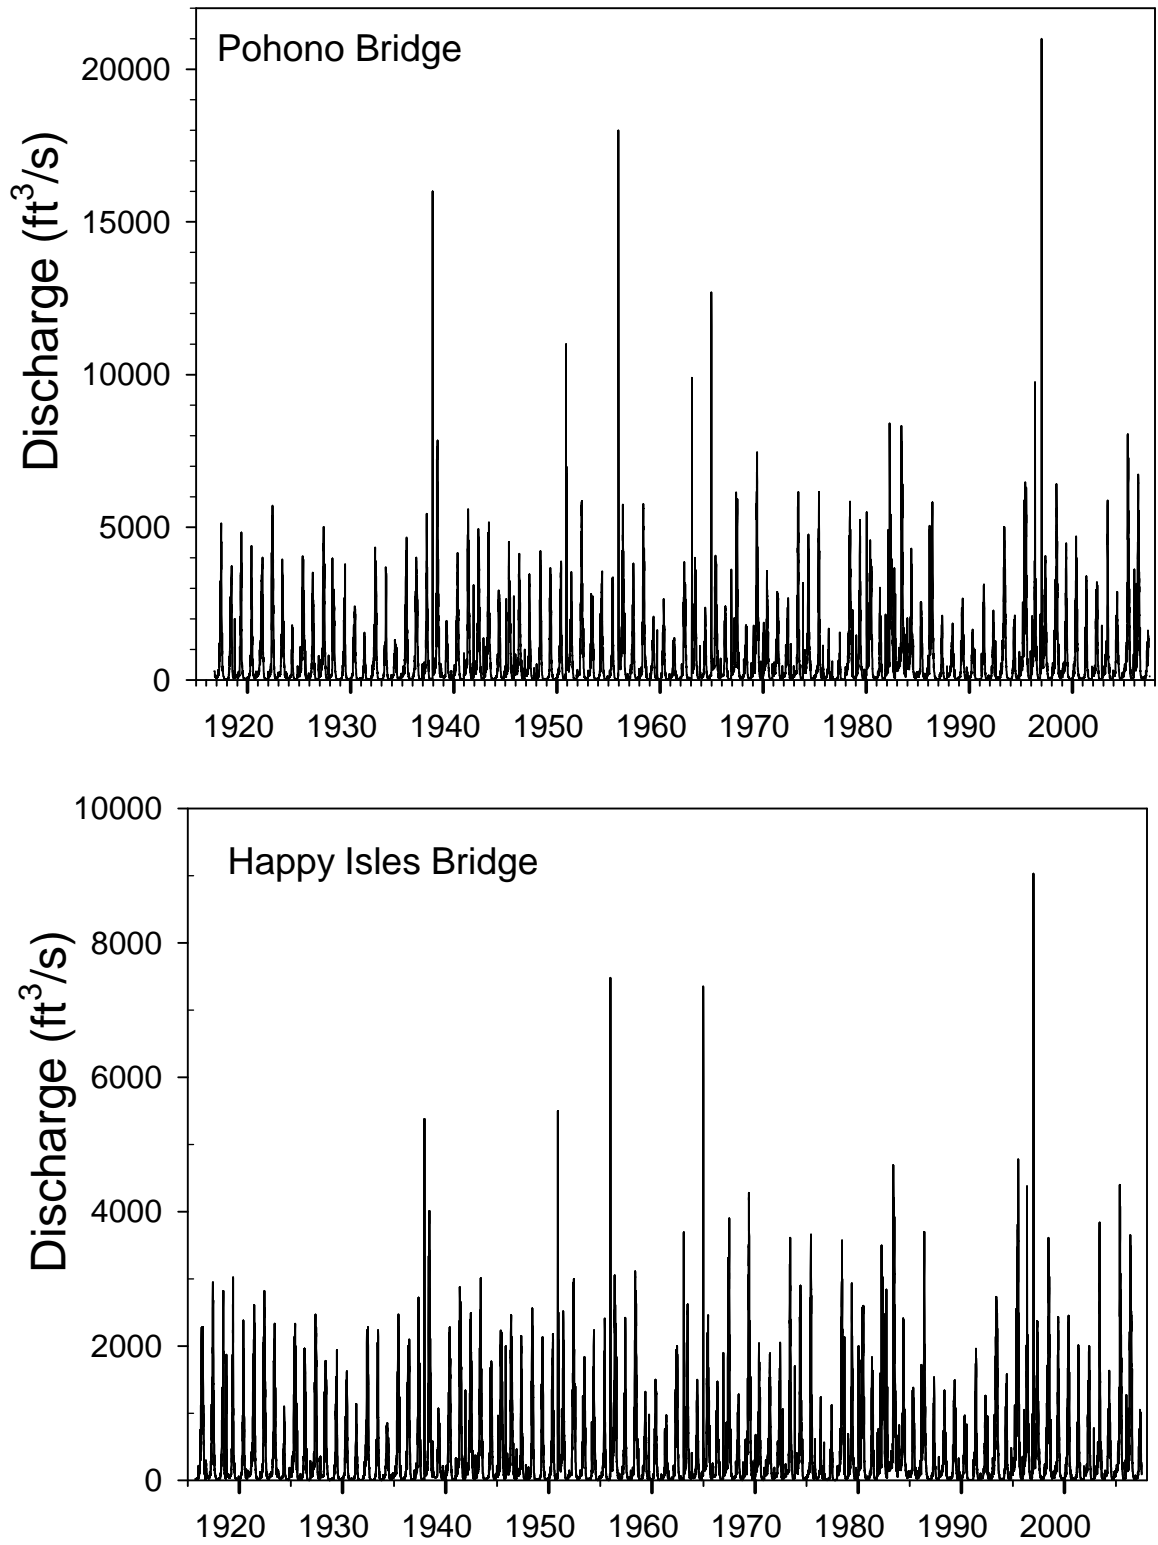
Figure 10. Mean daily flow at the Pohono Bridge and Happy Isles Bridge gauges, Merced River.

During the study period, 2004 had a low snowpack winter, with the lowest peak flows since 1994 (Figures 9, 10, 11). Even lower flows occurred in 2007, after this study was concluded. Very large spring snowmelt driven stream flows occurred in 2005 and 2006 (Figures 10, 11), with 2005 having one of the two largest spring flows on record at the Happy Isles gauge, and 2006 being only slightly lower.

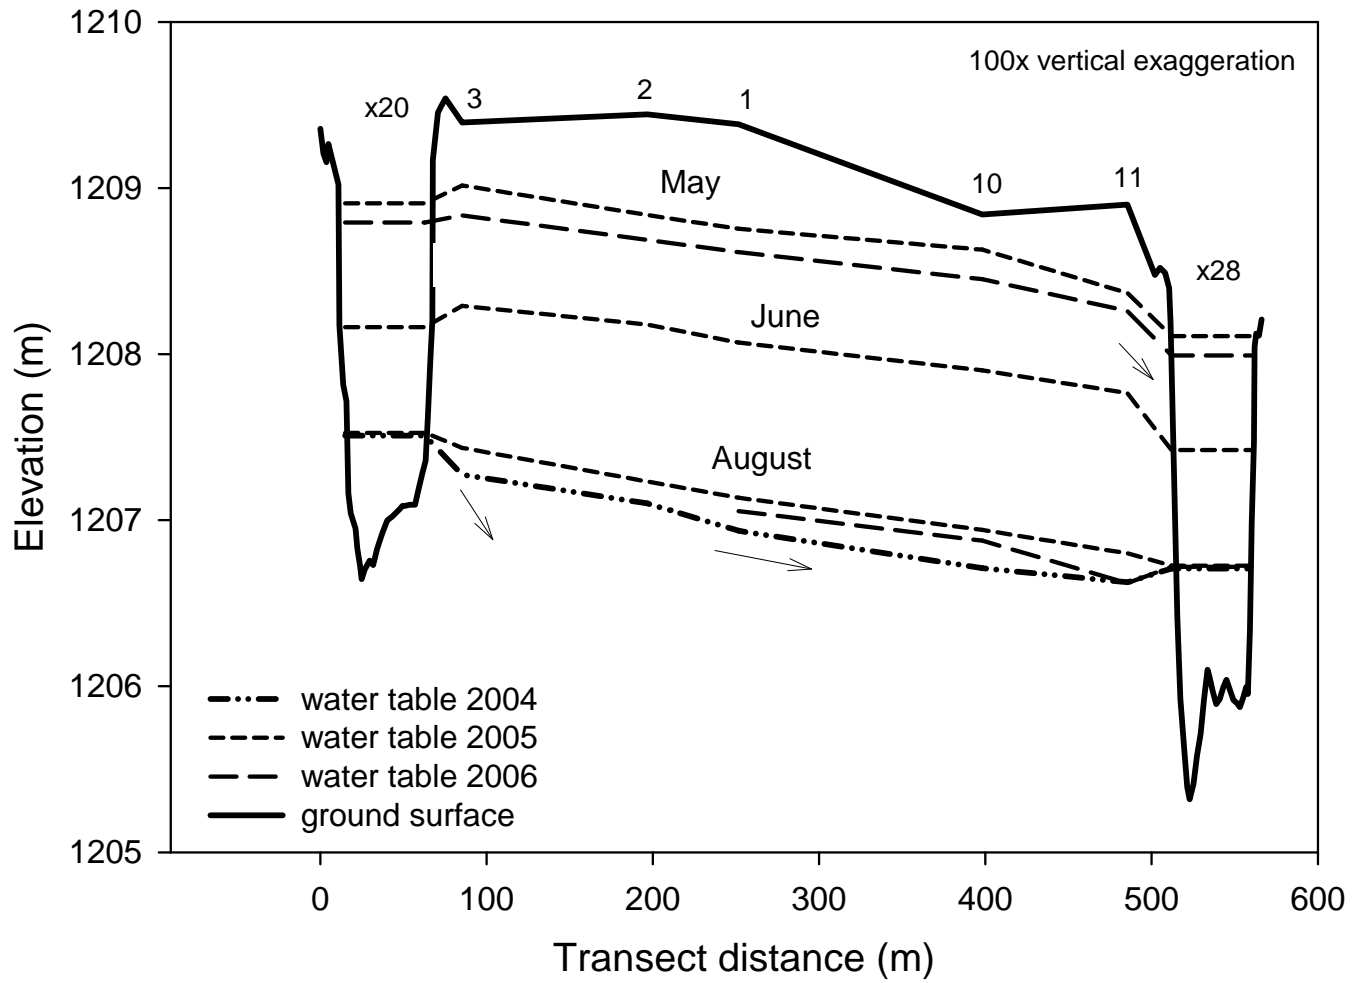
Figure 18. Ground surface, ground water and land surface elevation at wells 1, 2, 3, 10, 11 and surface water elevation at cross sections 20 and 28 for typical dates in May and August in 2004, 2005 and 2006.

The ground surface and water table elevation profile across the Rivers Campgrounds (Figure 18) indicates that the elevation of Merced River stage at X20 is always higher than ground water and the river is strongly losing into the ground water system. The downstream river cross section X28 also has a higher stage than adjacent ground water monitoring wells 10 and 11 at all times. Thus, this reach is also losing. We would expect that ground water flowing from X20 under the Rivers Campground would be higher than the river at X28 and flow into it. Because the Merced River is losing on both the upstream and downstream portion of this transect it suggests that drain(s) may exist in the campground area.

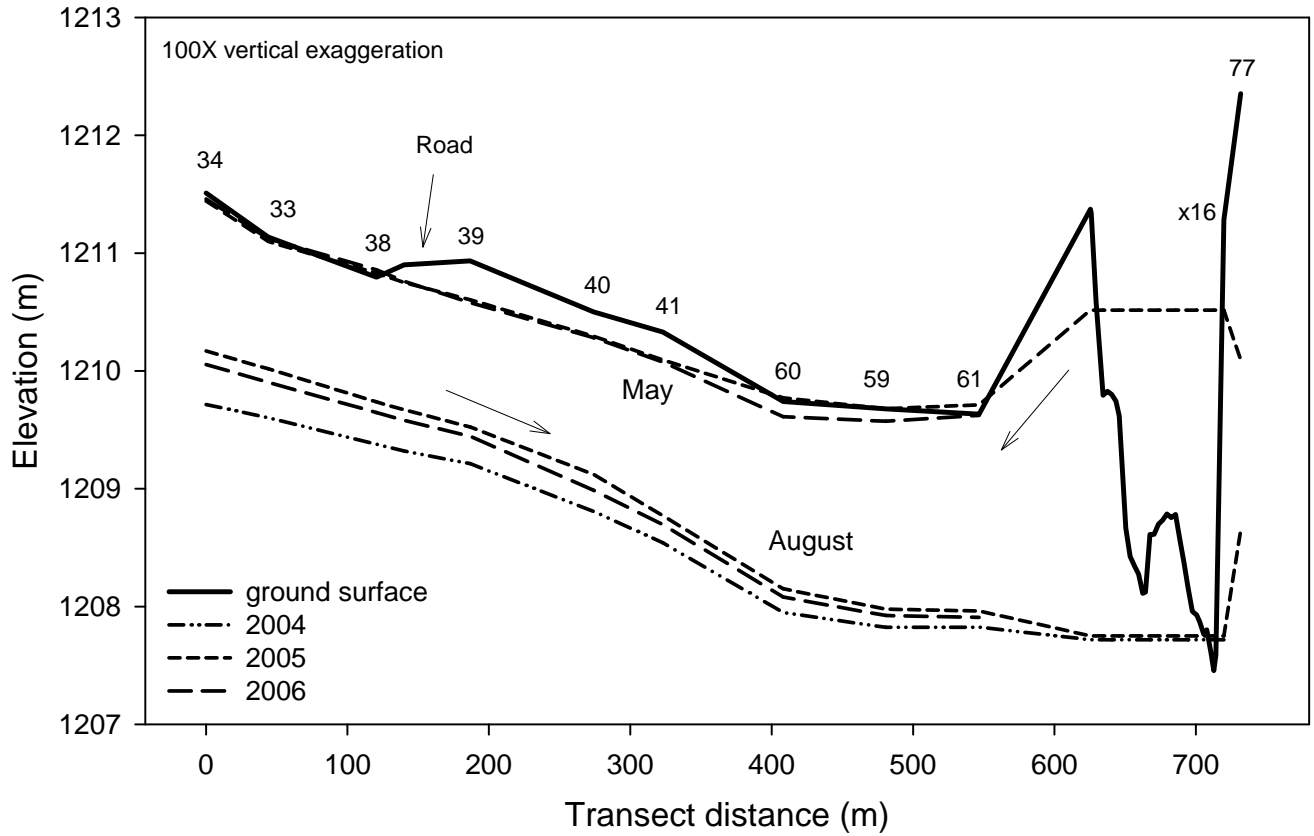
Figure 19. Ground surface, ground water and land surface elevation at wells 34, 33, 38, 39, 40, 41, 60, 59, 61, and 77 and surface water elevation at cross section 16 for typical dates in May and August in 2004, 2005 and 2006.

The water table elevation profile from well 34 through Stoneman Meadow and across Lower Pines campground to river cross section X16 shows river elevation is higher at peak stage in May 2005 and 2006 than wells 59, 60 and 61. Thus, the river is losing water to ground in the northern portion of the campground (Figure 19). However, ground water levels in upper Stoneman Meadow (wells 34 and 33) are always higher than water in other wells and ground water flows from Stoneman Meadow toward the Merced River. Wells 34, 33, 38, 39, 40 and 41 are supported by ground water flowing down Stoneman Meadow during the late summer, while wells 59, 60 and 61 appear connected to and approximately the same elevation as the Merced River.

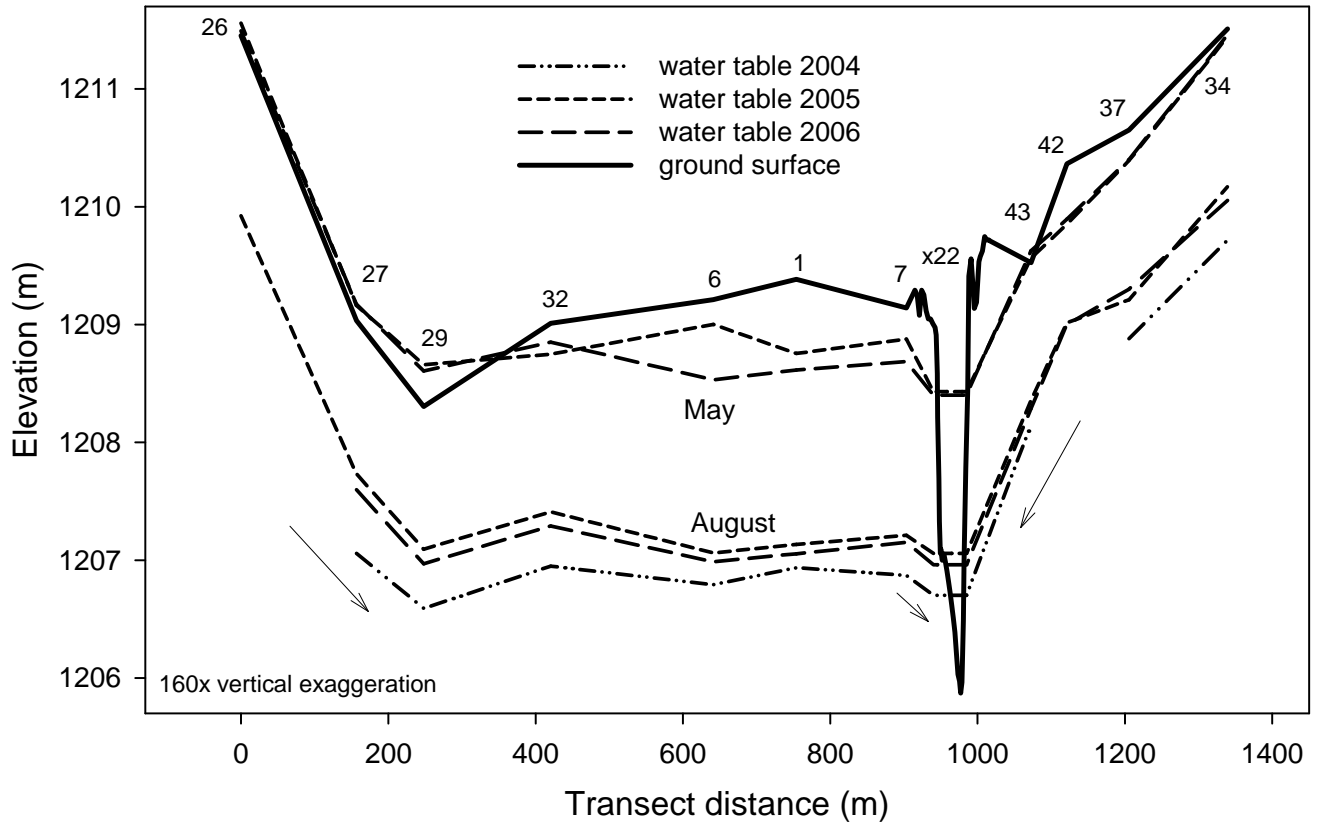
Figure 20. Ground surface, ground water and land surface elevation at wells 26, 27, 29, 32, 6, 1, 7, 43, 42, 37 and 34 and surface water elevation at cross section 20 for typical dates in May and August in 2004, 2005 and 2006.

The water elevation profile across the valley from well 26 to 34 (Figure 20) clearly shows ground water supported areas on both sides of the valley and an area connected to the Merced River in the valley center (X20, wells 7, 1, 6). Thus, both ground water supported, and stream water supported areas occur in the valley.

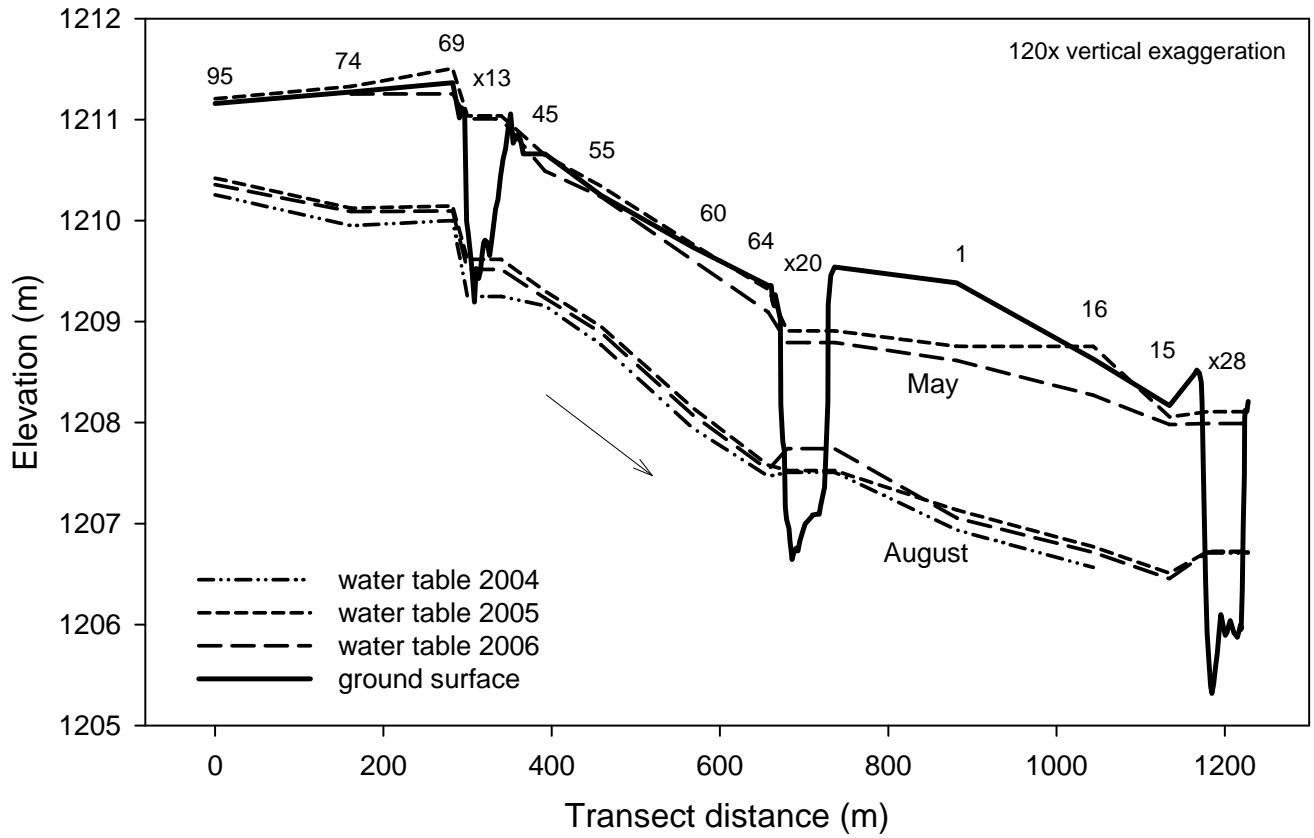
Figure 21. Ground surface, ground water and land surface elevation at wells 95, 74, 69, 45, 55, 60, 64, 1, 16, and 15 and surface water elevation at cross sections 13, 20, and 28 for typical dates in May and August in 2004, 2005 and 2006.

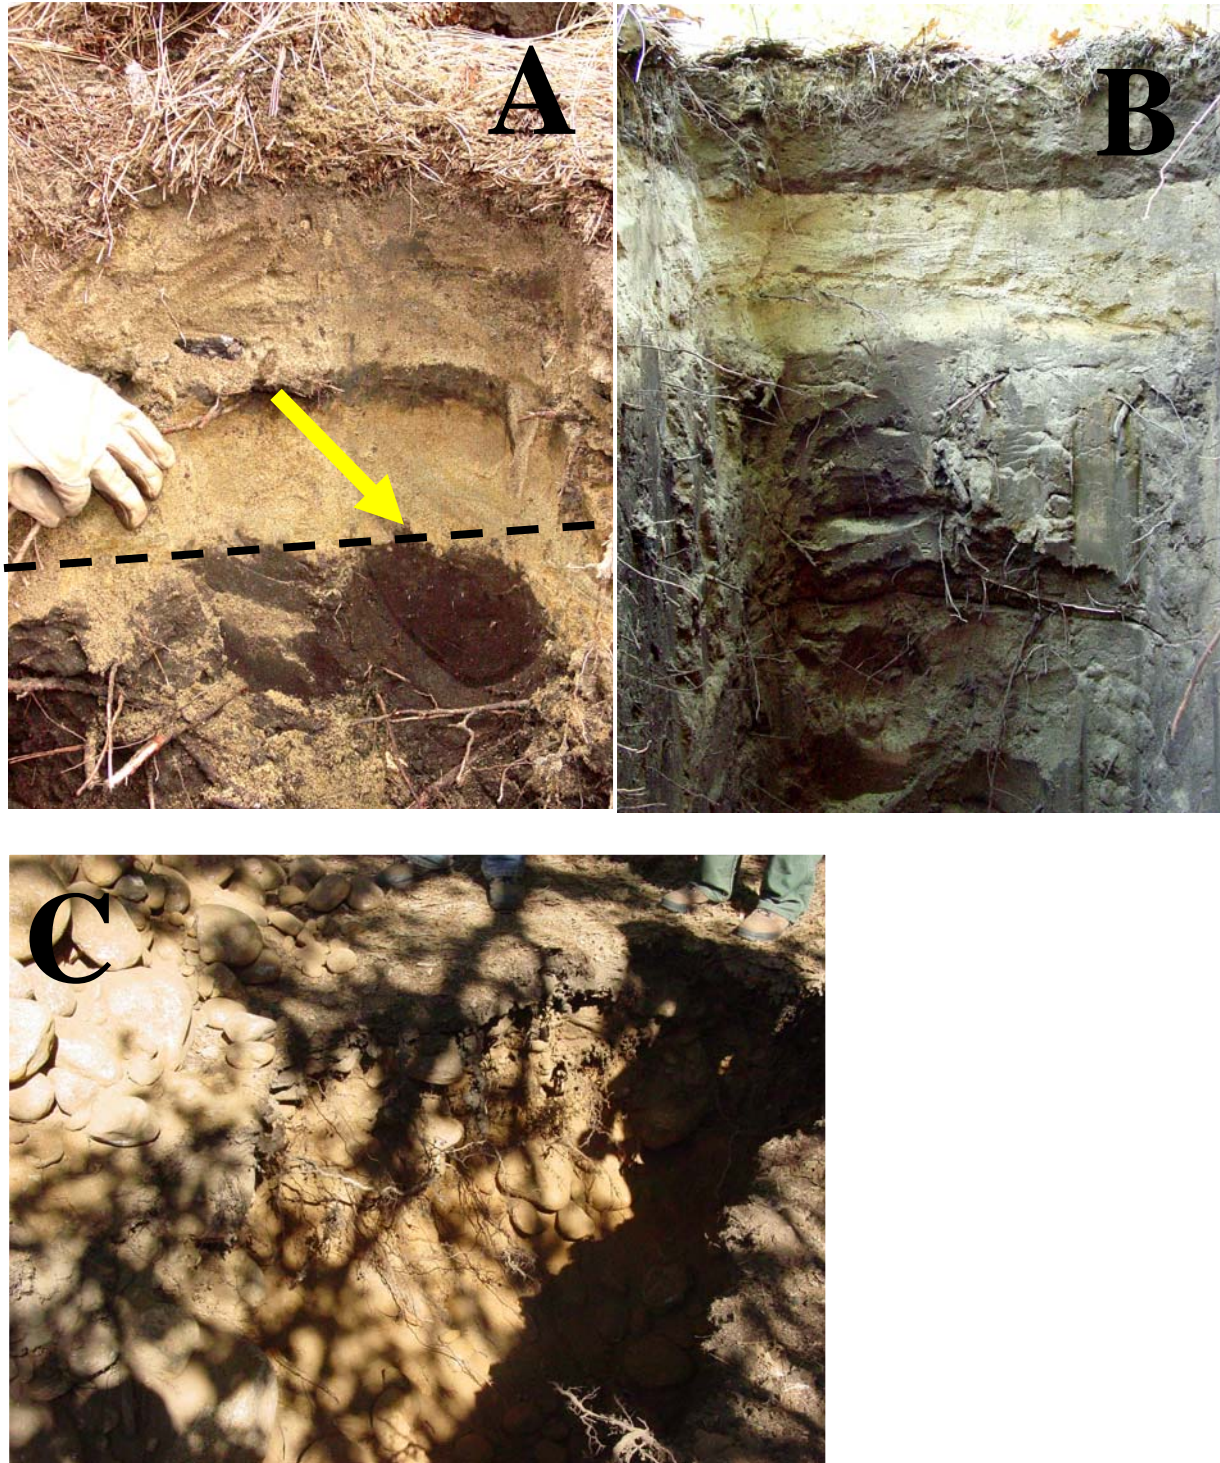
Figure 26. Three soil profiles in backhoe pits. A shows a very dark, organic rich soil (below dashed line) with some sandy layers above. B shows a dark surface horizon, a sandy buried soil, and a dark buried soil below the sand. C shows a cobble soil.

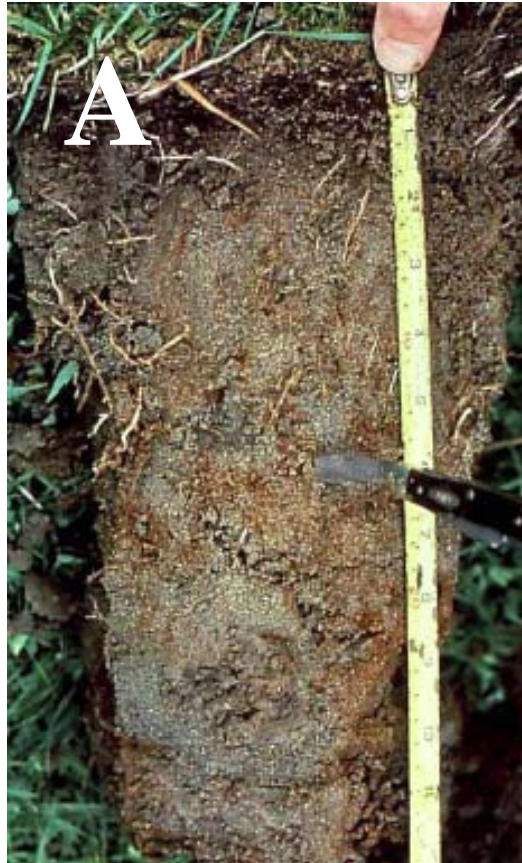
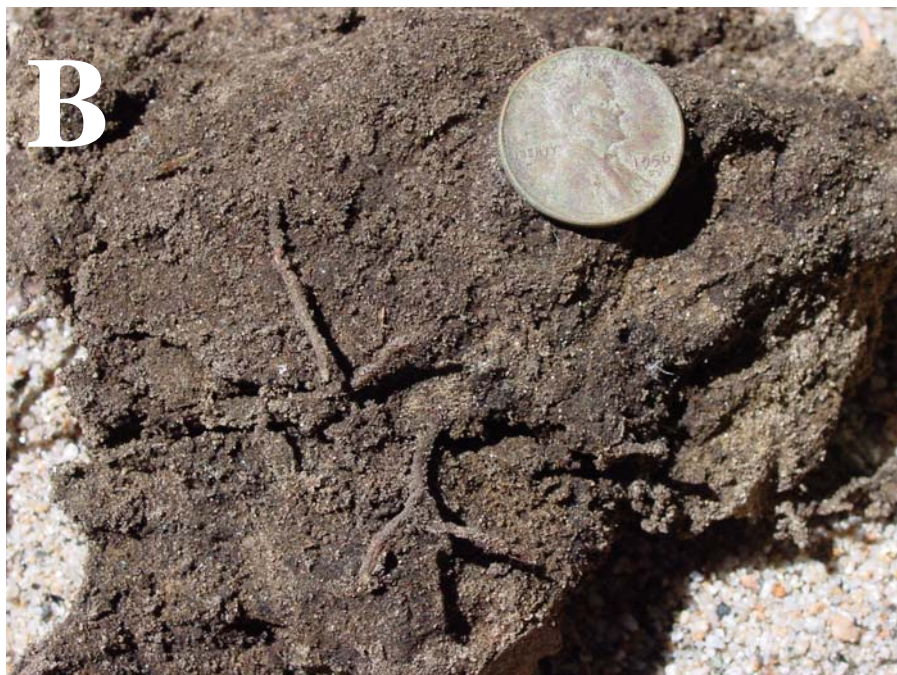
Figure 27. Examples of bright (A) and faint mottles (B) in study area soils.

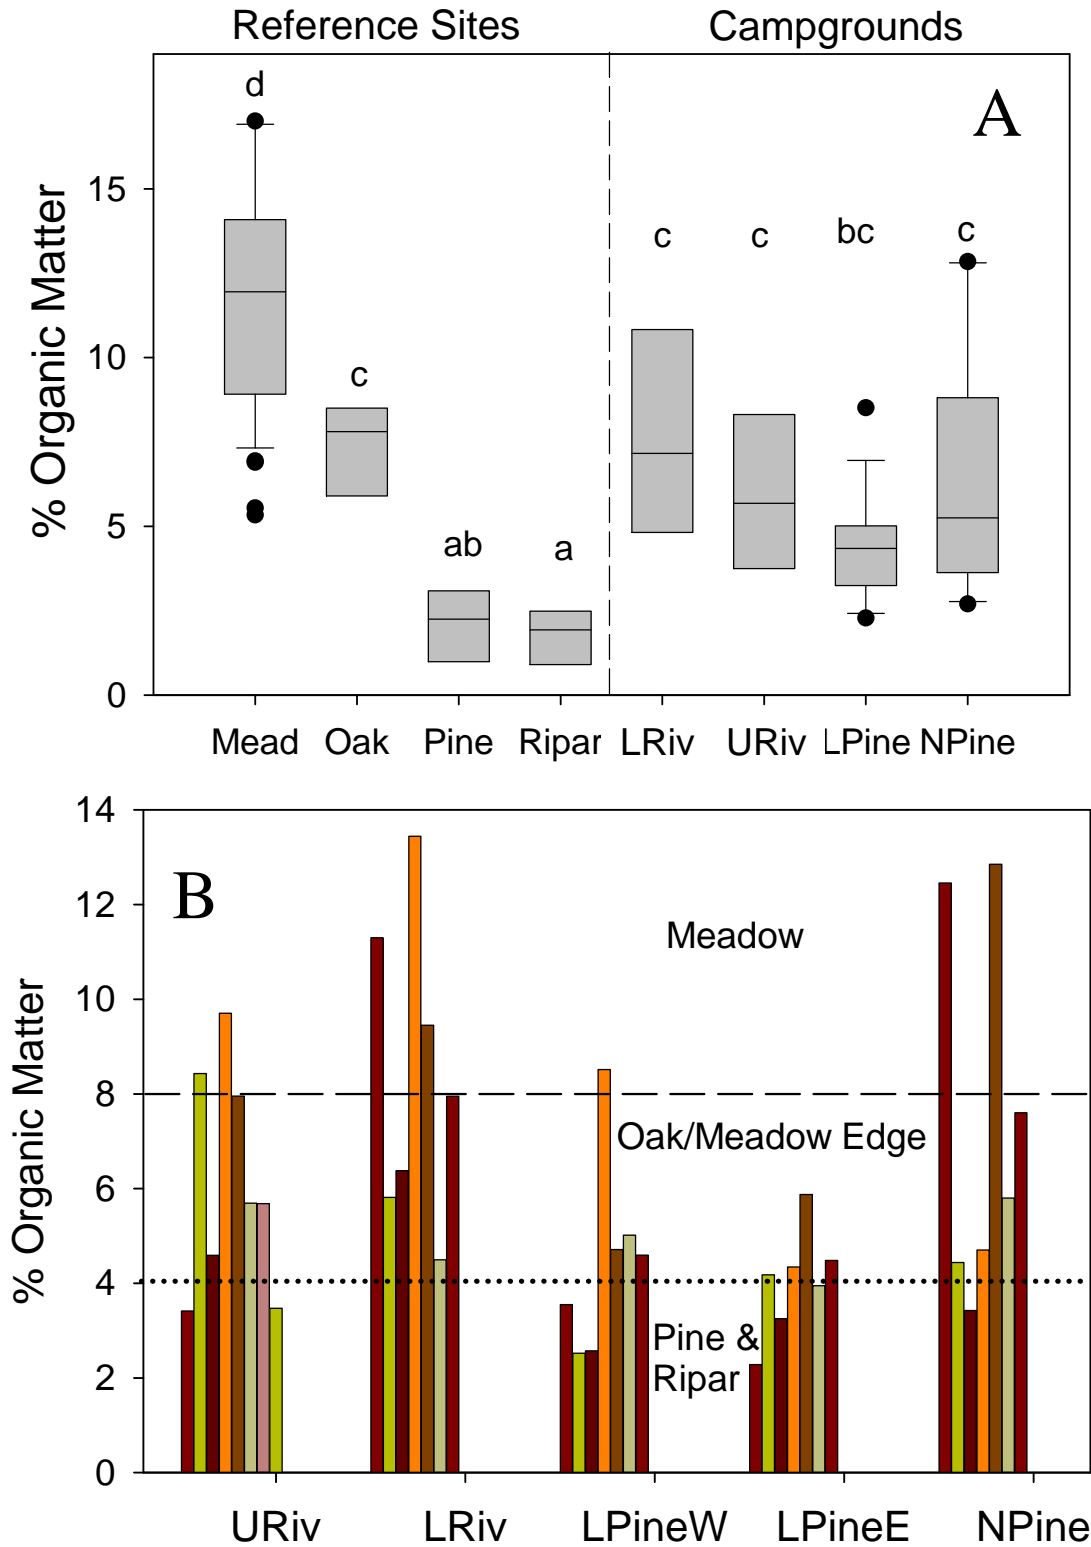
Figure 29. Percent organic matter in soils. A. Box plots showing mean \pm 1se, plus extremes for reference areas and campgrounds. B. % OM for campground wells. Boundaries for %OM indicate the range of meadow, oak forest/meadow margins, pine and riparian areas. Sites with different lower case letters are statistically significantly different.

Reference meadows in Yosemite Valley (including wet and dry meadows) averaged 12.5 % organic matter, oak forests 7.0 %, mixed conifer forest 2.9 %, and riparian areas 1.8 % (Figure 29). The Upper River, Lower River, Lower Pines and North Pines campgrounds had mean organic contents of 8.4, 6.1, 4.6, and 7.0 %, respectively. Of the 36 campground sites, 9 have soil OM similar to meadows, 18 similar to oak forest and meadow margins, and 9 pine forest or riparian soils.

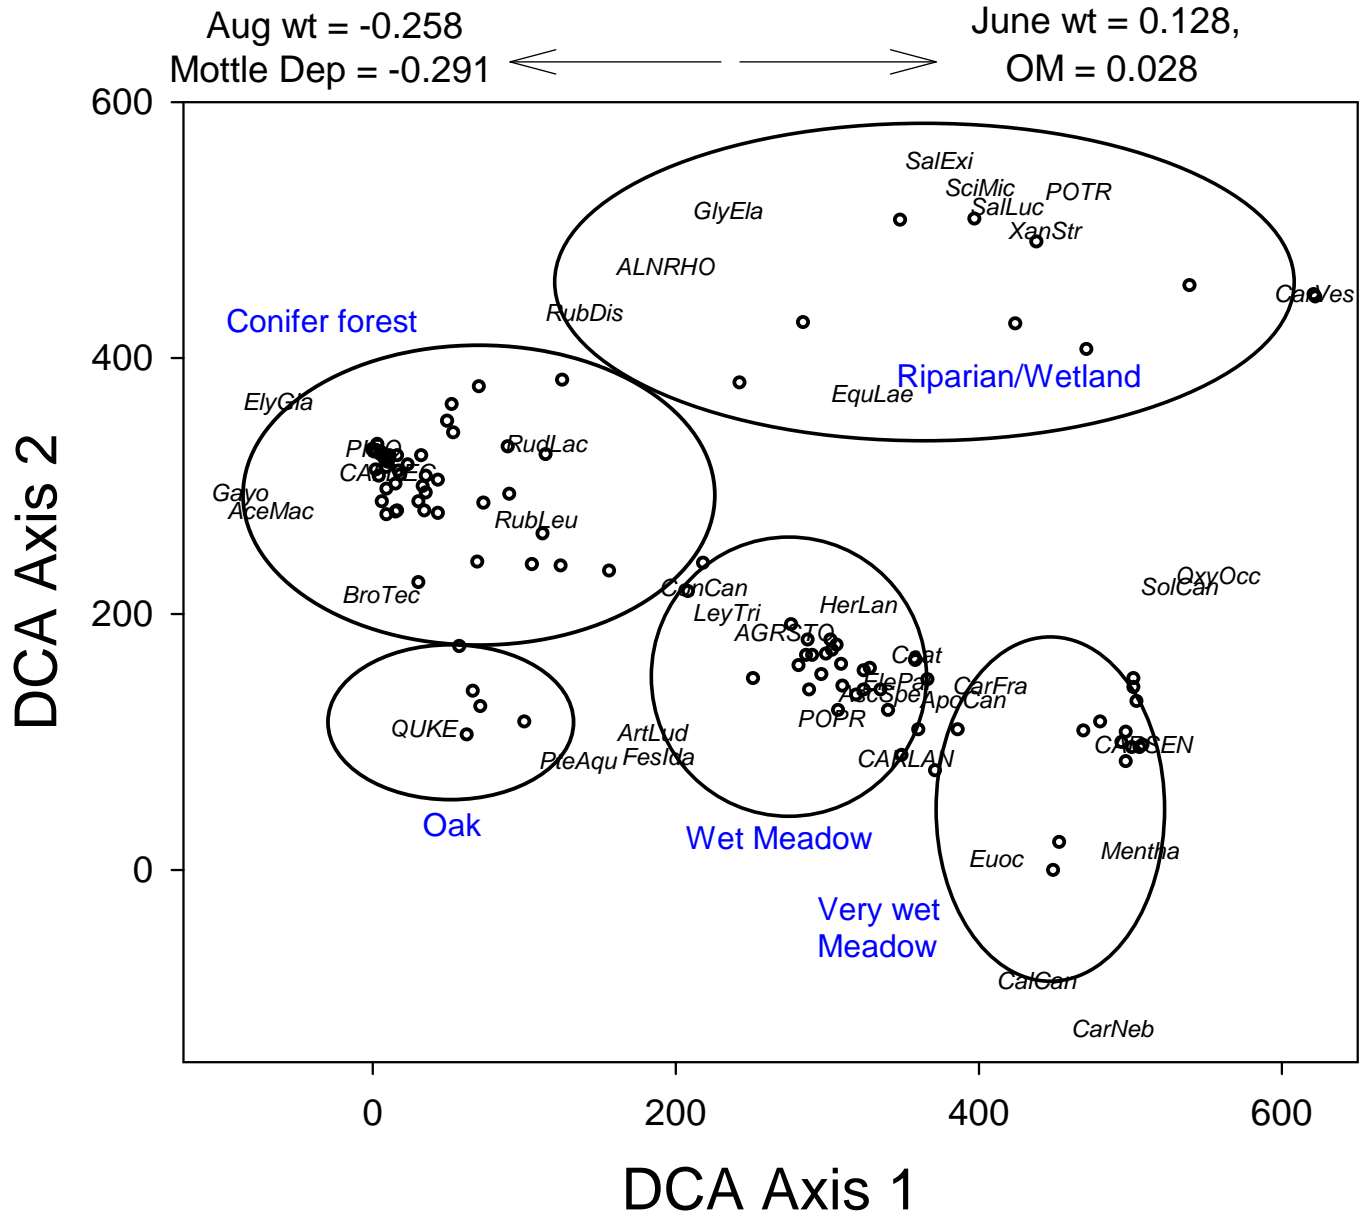
Figure 34. Indirect ordination, using detrended correspondence analysis (DCA) on all vegetation data in the study area. Axes are in standard deviation units (see text). Correlations of site scores with selected environmental variables are shown at top of figure. Ovals identify plots with similar vegetation composition and are grouped into conifer forests, riparian/wetland, oak forests, wet meadows, and very wet meadows.

DCA analysis of vegetation stand floristic composition data indicates that a wide range of vegetation types occur in the study area (Figure 34). The DCA axes have a gradient length of 600 SD units along both axes 1 and 2 indicating high species turnover within the ordination space. The left side of the ordination space is occupied by conifer forest stands dominated by *Pinus ponderosa* and *Calocedrus decurrens* with varying understory composition, but dominated by *Bromus tectorum* and *Conyza canadensis*. The top portion of the ordination space is occupied by riparian stands dominated by *Alnus rhombifolia*, *Populus trichocarpa* and *Salix* spp. as well as monocultures of *Carex vesicaria*, a sedge species that occupies deeply flooded ox bow ponds and other basins. The bottom left portion of the ordination space is occupied by stands of *Quercus kelloggii* that occur on wet meadow margins. The central portion of the ordination space is occupied by wet meadows with floristic composition varying from sites with deep summer water tables and supporting *Poa*

campgrounds (Figure 34B) and areas with high density of large *Quercus* trees likely supported wet meadow and *Quercus* dominated stands in a mosaic with other community types.

Several wet meadow community types occur in the study area, dominated by *Carex senta*, *C. lanuginosa*, *Agrostis stolonifera* and *Poa pratensis* (Figure 34A). Areas suitable for each community type are determined by the long-term summer maximum water table depth and its duration. A typical hydrograph for five major wet meadow and *Quercus* communities is shown in Figure 40, illustrating important differences in early and late summer water table depth.

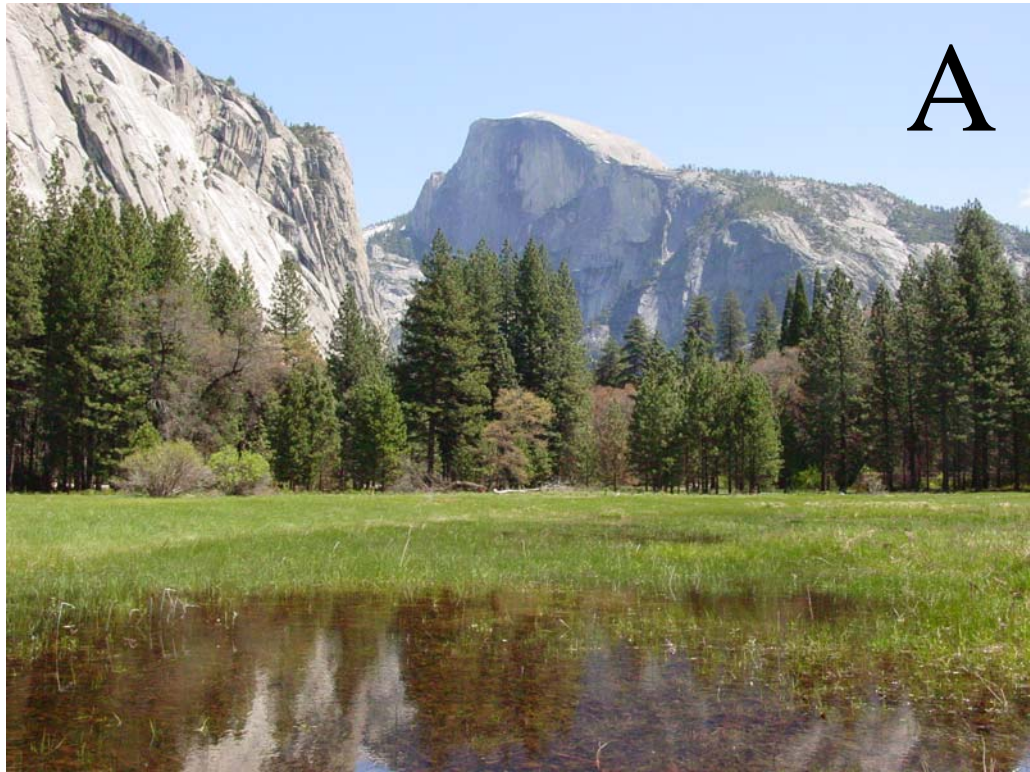
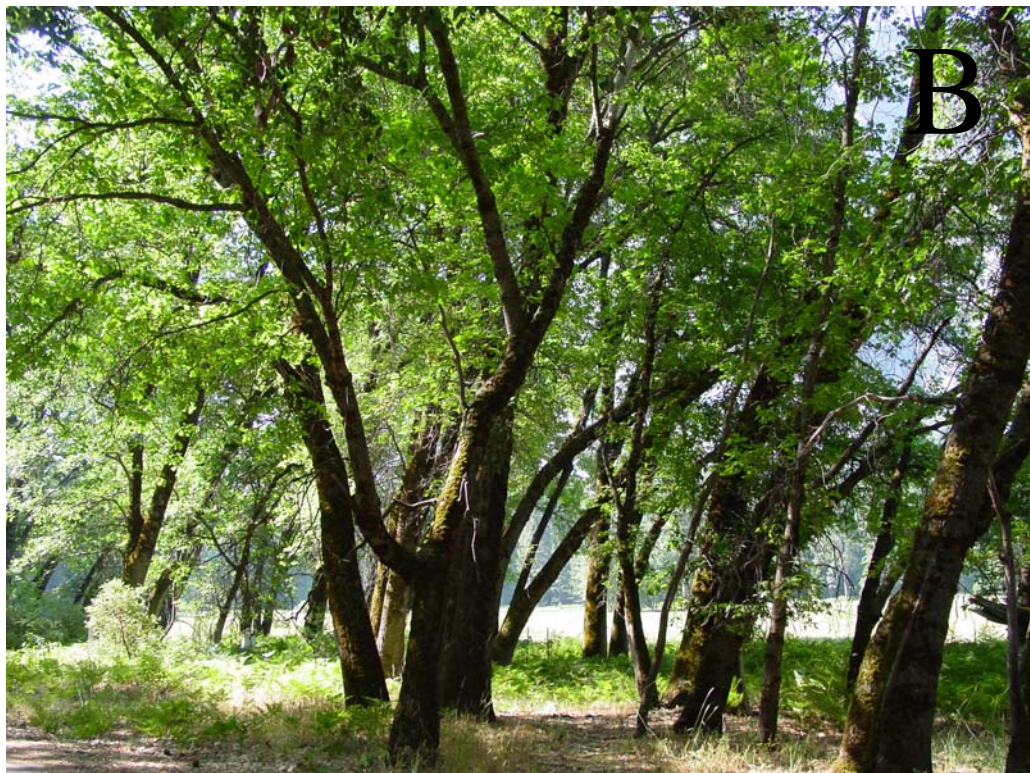
Figure 35. Typical wet meadow (A) (Ahwahnee), *Quercus kelloggii* forest (B), upland conifer forest (C), and riparian zone (D).

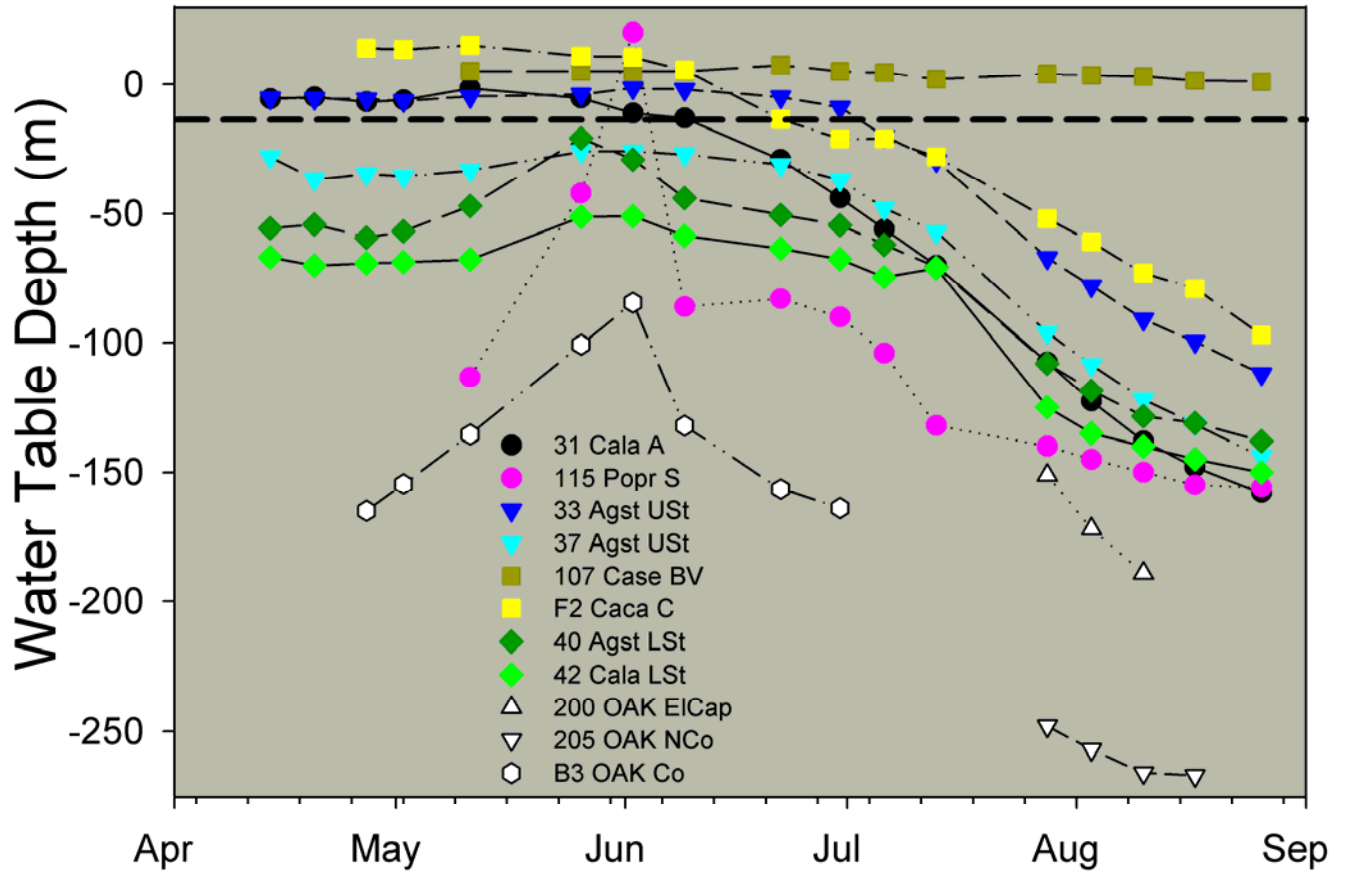
Figure 40. Typical summer water table depths during 2005 and 2006 for *Carex lanuginosa* (Car lan), *Poa pratensis* (Poa prat), *Agrostis stolonifera* (Agr stol), *Carex senta* (Car senta), and *Quercus kelloggii* (Que kel) dominated stands in the study area.

The hydrologic restoration goal for wet meadows should be a water table near the soil surface from April through mid July of most years (see Figure 40), with the water table depth
