Yosemite Valley:

Hydrologic Regime, Soils, Pre-Settlement Vegetation, Disturbance, and Concepts for Restoration

David J. Cooper, Ph.D. and Evan C. Wolf, M.S.
Department of Forest, Rangeland and Watershed Stewardship
Colorado State University, Fort Collins, CO 80523

September 2008

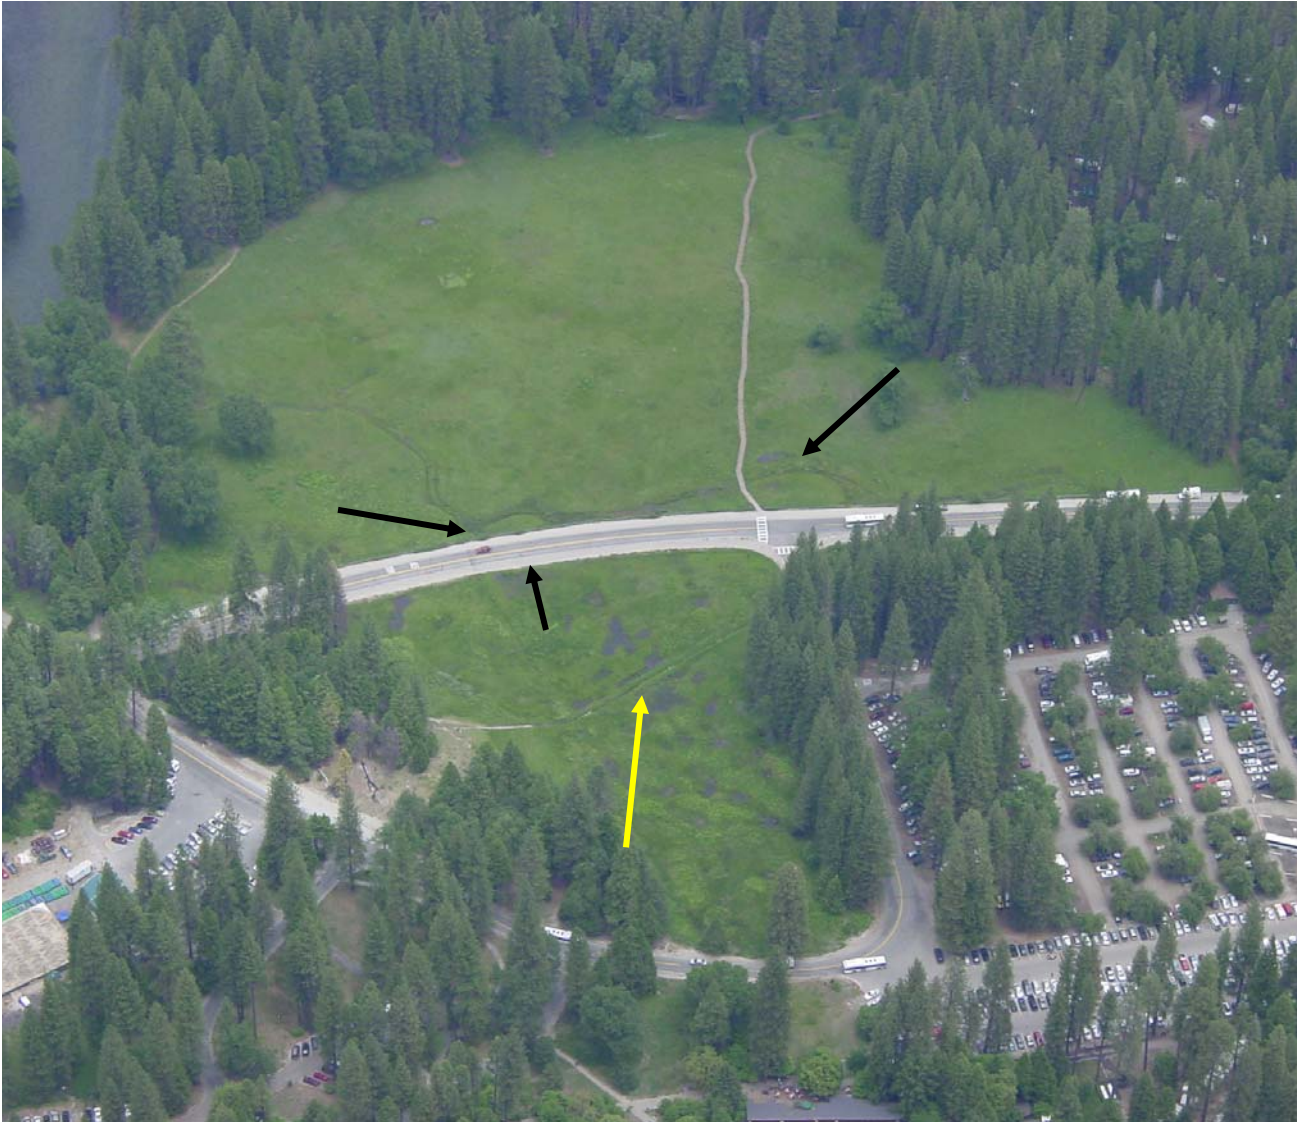
Figure 41. Photo of Stoneman Meadow from Glacier Point, with arrows identifying surface features that appear to drain ground water from the meadow.

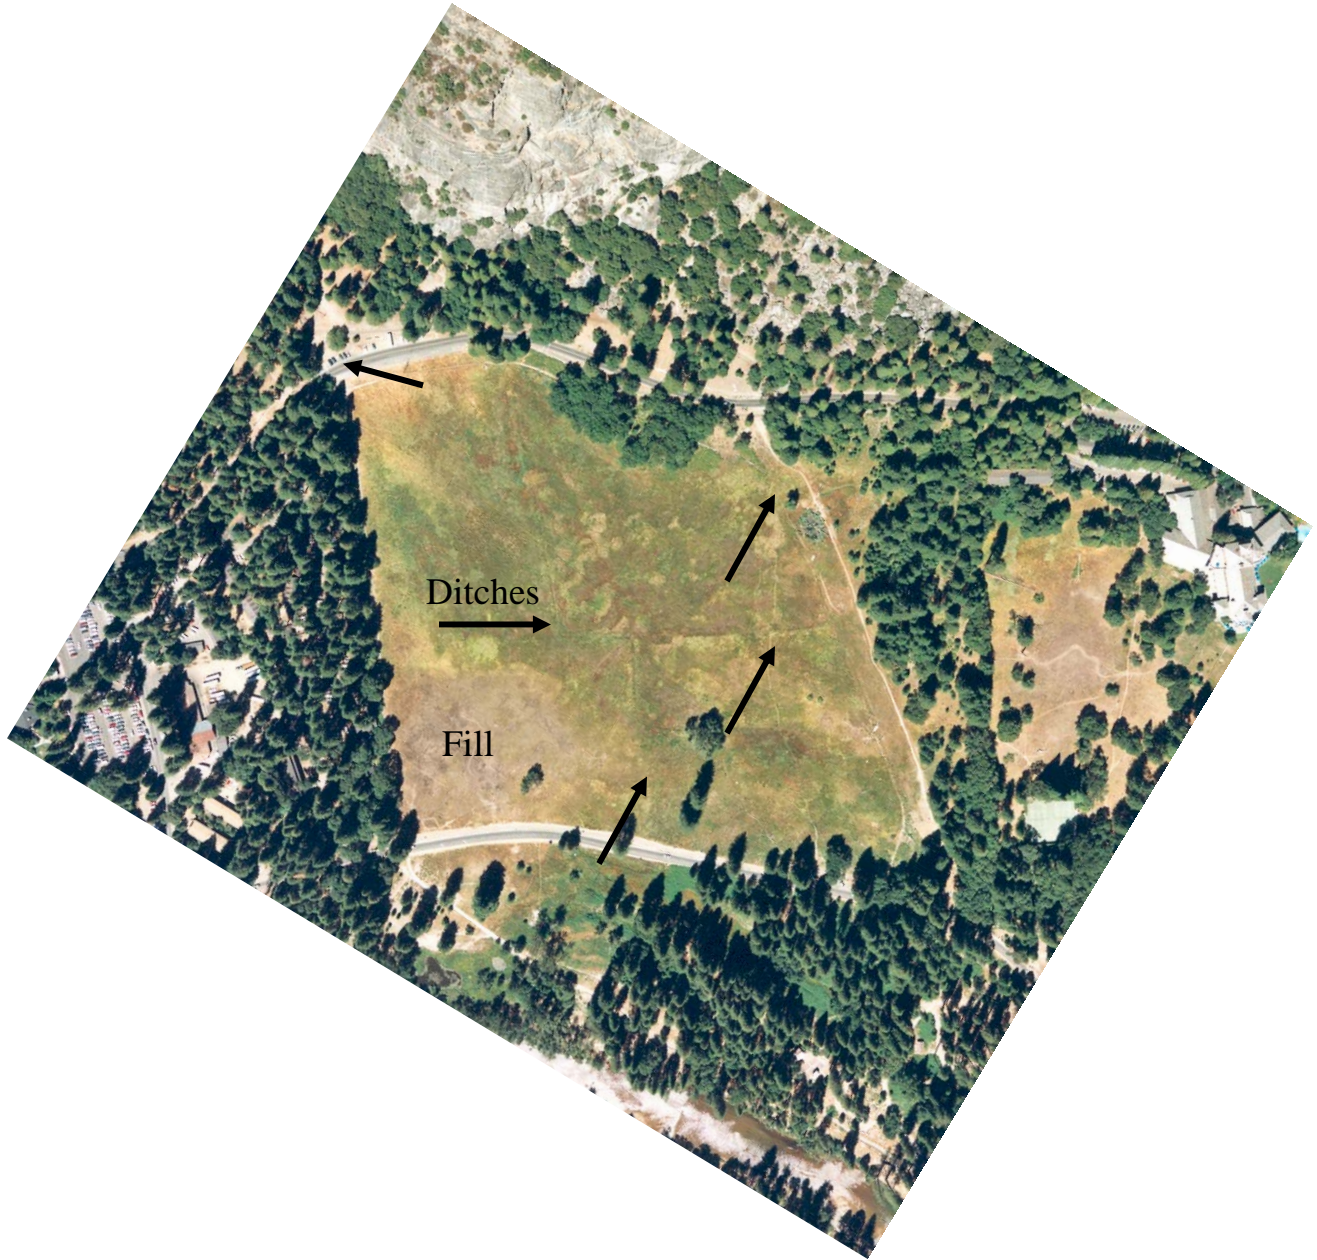
Figure 43. Air photo of Ahwahnee Meadow showing the location of ditches, fill and other impacts.

A large area of fill is present in the southwestern corner of Ahwahnee Meadow. In addition a sewer line bisects the meadow, a ditch runs the meadow length, and drains or pipes occur in the northeastern corner of the meadow (Figures 42, 43). Surface water draining toward Ahwahnee Meadow from the northwest is captured in ditches and drained west before
