# Geomorphic Responses to Post-Grazing Recovery and Stream Restoration in Semiarid Grassland Streams

Owen Richardson | Ellen Wohl

Department of Geosciences, Colorado State University, Fort Collins, Colorado, USA

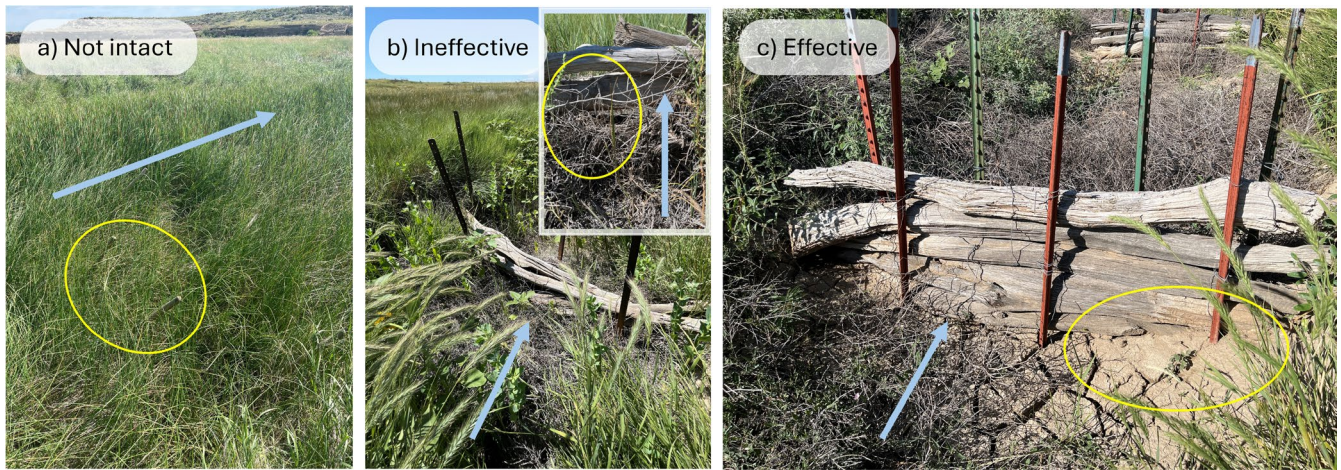
**FIGURE 4** | Categorization of log-based erosion control structure outcomes as (a) not intact, (b) intact but ineffective, not resulting in detectable geomorphic change, and (c) intact and effective, resulting in detectable geomorphic change. Blue arrows indicate flow direction. [Color figure can be viewed at [wileyonlinelibrary.com](https://onlinelibrary.wiley.com)]

Post-assisted log structures (PALS) can take on a variety of forms; at SPLT, they typically feature small vertical stacks of logs or wooden fence posts, secured by posts driven into the channel bed (Figure 4). Figure 4a shows a PALS destroyed during a high-flow event, with only the posts remaining intact. Figure 4b shows an intact but ineffective log structure, trapping windblown vegetation but little sediment. Figure 4c shows an effective log structure, with fluvial sediment deposition visible upstream of the structure.

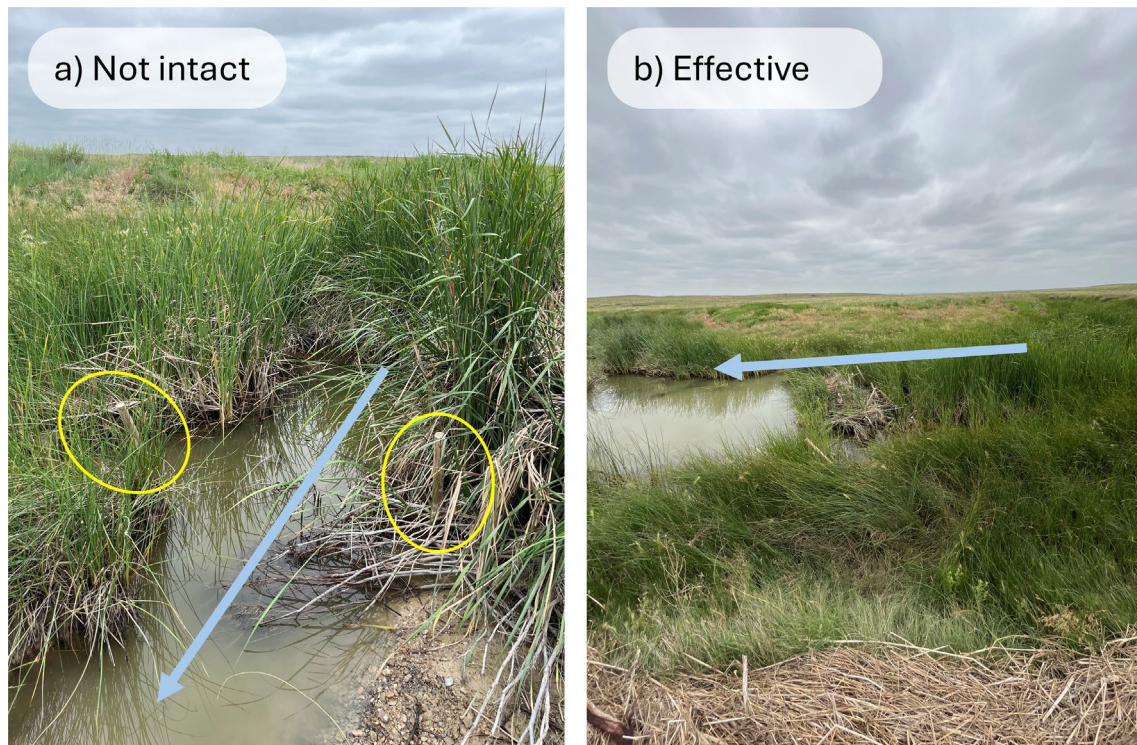
**FIGURE 5** | Categorization of beaver dam analog (BDA) outcomes as (a) not intact and (b) intact and effective, resulting in detectable geomorphic change. Blue arrows indicate flow direction. [Color figure can be viewed at [wileyonlinelibrary.com](https://onlinelibrary.wiley.com)]

Because the BDAs produced pronounced and persistent back-water effects and deep pools, we surveyed longitudinal and cross-sectional profiles to qualitatively assess how they altered bed conditions and how site geomorphology contributed to their success or failure.

The small BDA sample size ( $n = 3$ ) makes statistical modeling ineffective for identifying factors contributing to restoration outcomes. All three BDAs were installed along a deeply incised, low-gradient section of Mud Creek with perennial flow and an upstream catchment area of ~82 km<sup>2</sup>. The valley bottom here is densely vegetated with sedges and grasses, and all sites fall within the “recent” commercial grazing regime (Figure 5). Two BDAs remained intact and produced extensive upstream backwater and fine sediment deposition, while the third failed. The failed structure was located in a slightly more confined reach

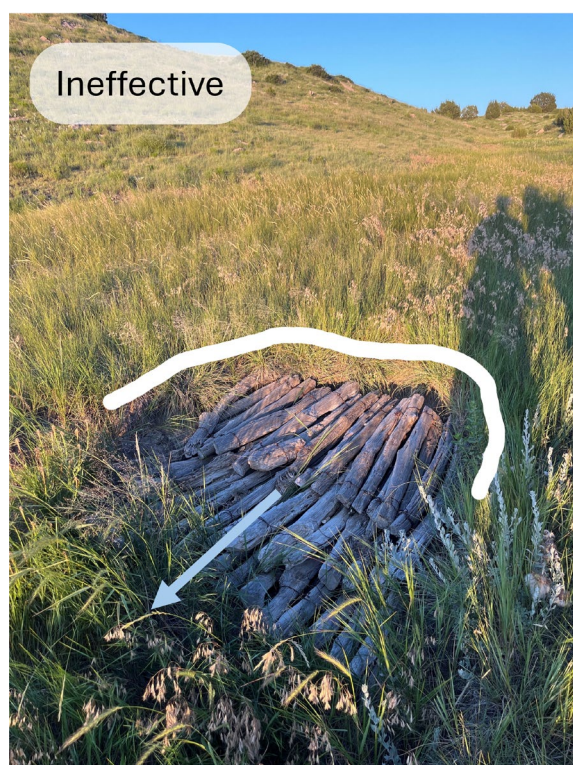
**FIGURE 6** | Ineffective log step-fall structure. White outline indicates approximate piping-collapse headcut scarp; blue arrow indicates flow direction. [Color figure can be viewed at [wileyonlinelibrary.com](https://onlinelibrary.wiley.com)]

Placed within a piping collapse, the log step-fall structure shown in Figure 6 fails to address a subsurface-driven erosion process with surface-based treatment. The absence of deposition within or upstream of the structure indicates that it does not interact with surface flow or fluvial sediment transport; rather, the logs simply cover evidence of the surrounding depression caused by subsurface erosion.
