Aerial Mulching

Field trip to Cameron Peak Fire

J.W. Associates and Coalition of the Poudre River Watershed invited partners to the Black Hollow Watershed to observe aerial mulching in a high severity burn area of the 2020 Cameron Peak Fire.

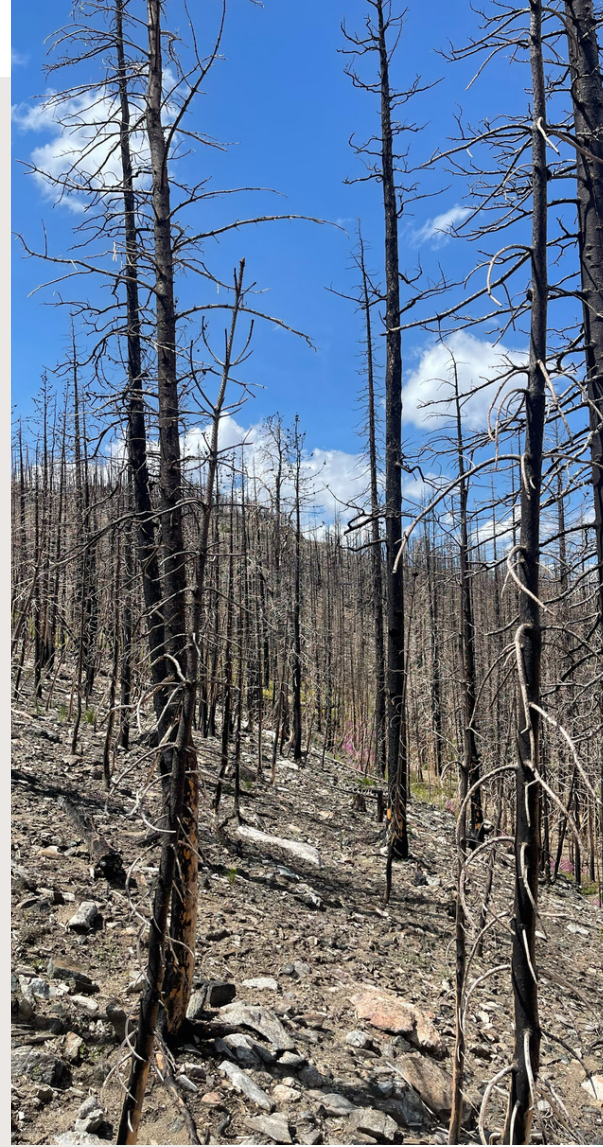
The burn severity mapping was revised in the fall of 2021 using a dNBR (different normalized burn ratio) analysis. This approach uses before imagery and compares it to post-fire imagery. The analysis was completed by Colorado State University, Colorado Forest Restoration Institute and JW Associates. The results are shown on the attached map.

One of the challenges with this fire was that it burned late into the fall and portions of the fire burned during a high wind event and was basically put out by snow. Evaluating the soil burn severity was a challenge because it is based on satellite data with ground verification. The analysis, planning, initial priorities, and treatments were based on burn severity mapping that was inaccurate in some locations. Field work during the summer of 2021 identified a number of locations that had higher burn severity than what was initially mapped.

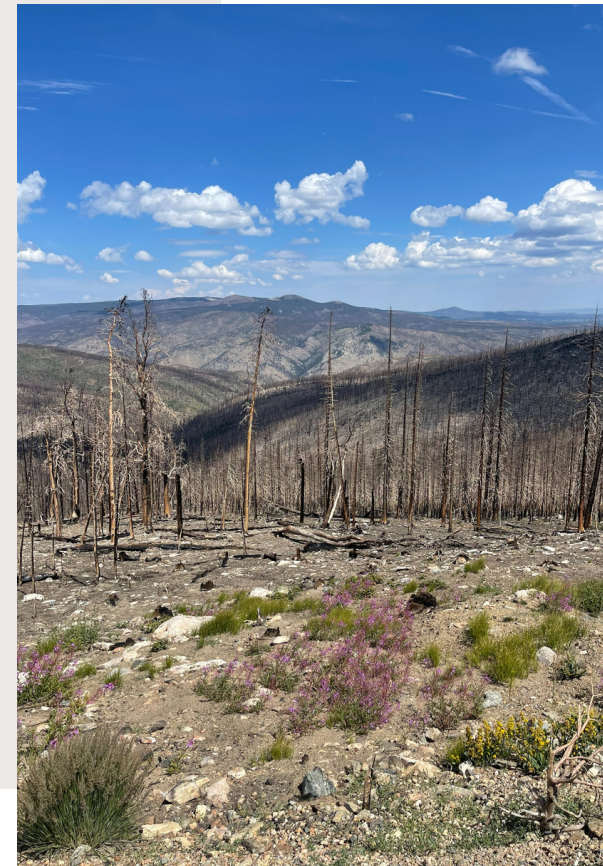
POST-FIRE WATERSHED HAZARD ANALYSIS

Watersheds were prioritized for post-fire treatment the components of the prioritization are shown on the chart. This prioritization was further revised in 2022 to include past mulch areas and areas identified for point protection projects.

Soil Burn Severity Map created with dNBR (Vorster and Woodward, CSU)

Gross Hillslope Erosion from Colorado Forest Restoration Institute (CFRI), re-modeled using dNBR

USGS Analysis of Debris Flow Hazard, re-modeled using dNBR

Road density, Roads within 100m of streams, Road/stream crossings

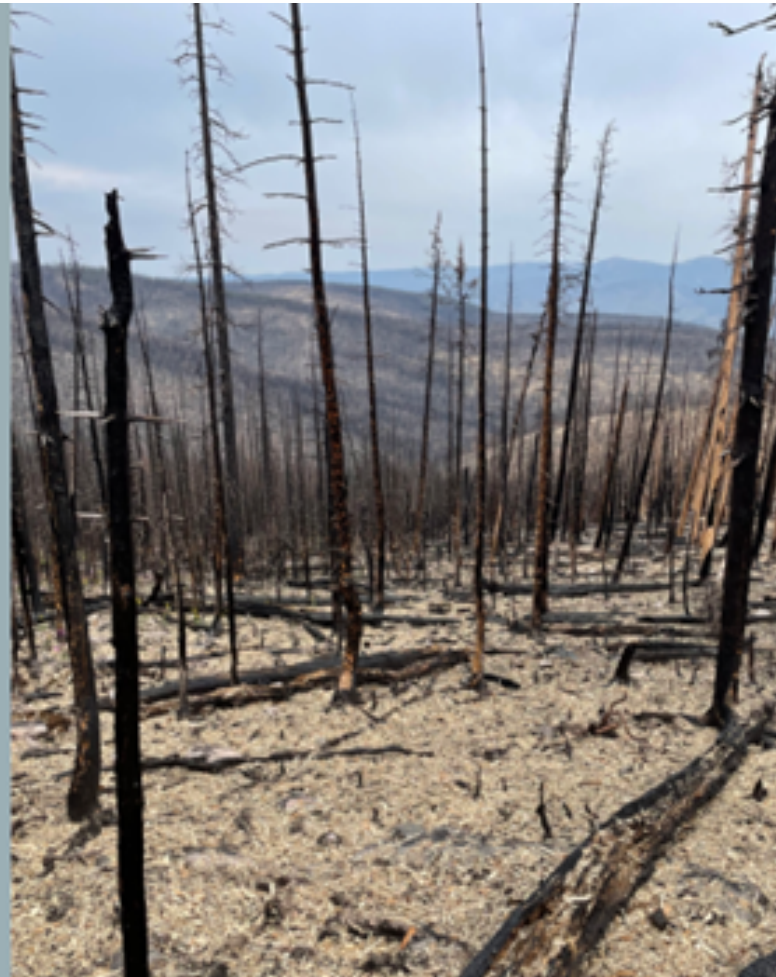
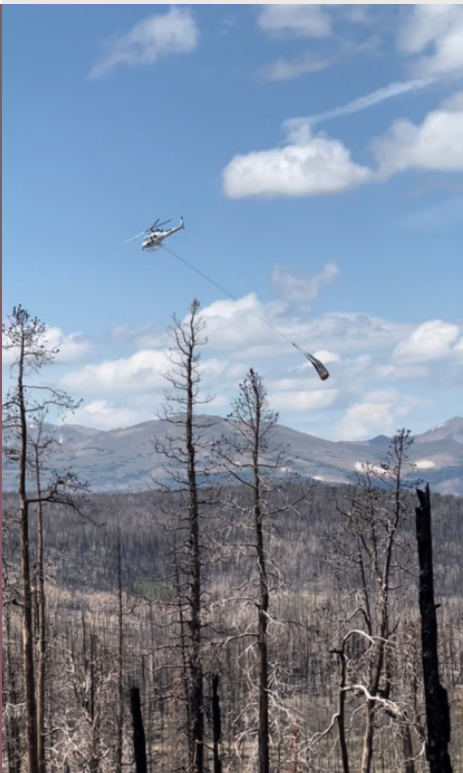
1. Keeping the soil on the hillslopes, reduces erosion.
2. Adds texture to the soil and slows down water as it runs downhill, reducing peak flows, storm runoff, debris flow initiation.
3. Aids in vegetation recovery by keeping the soils moist and cool after rainfall – just like in your garden!
4. Using wood mulch does not introduce weeds or invasives.

Aerial wood mulch has been applied to over 5,000 acres in the Poudre Watershed in 2021, costing about \$11.4 million. For 2022 over 3,600 acres are expected to be mulched in the Poudre Watershed. In the Big Thompson Watershed, over 700 acres were mulched in 2021 and 1,200 acres are planned for 2022.

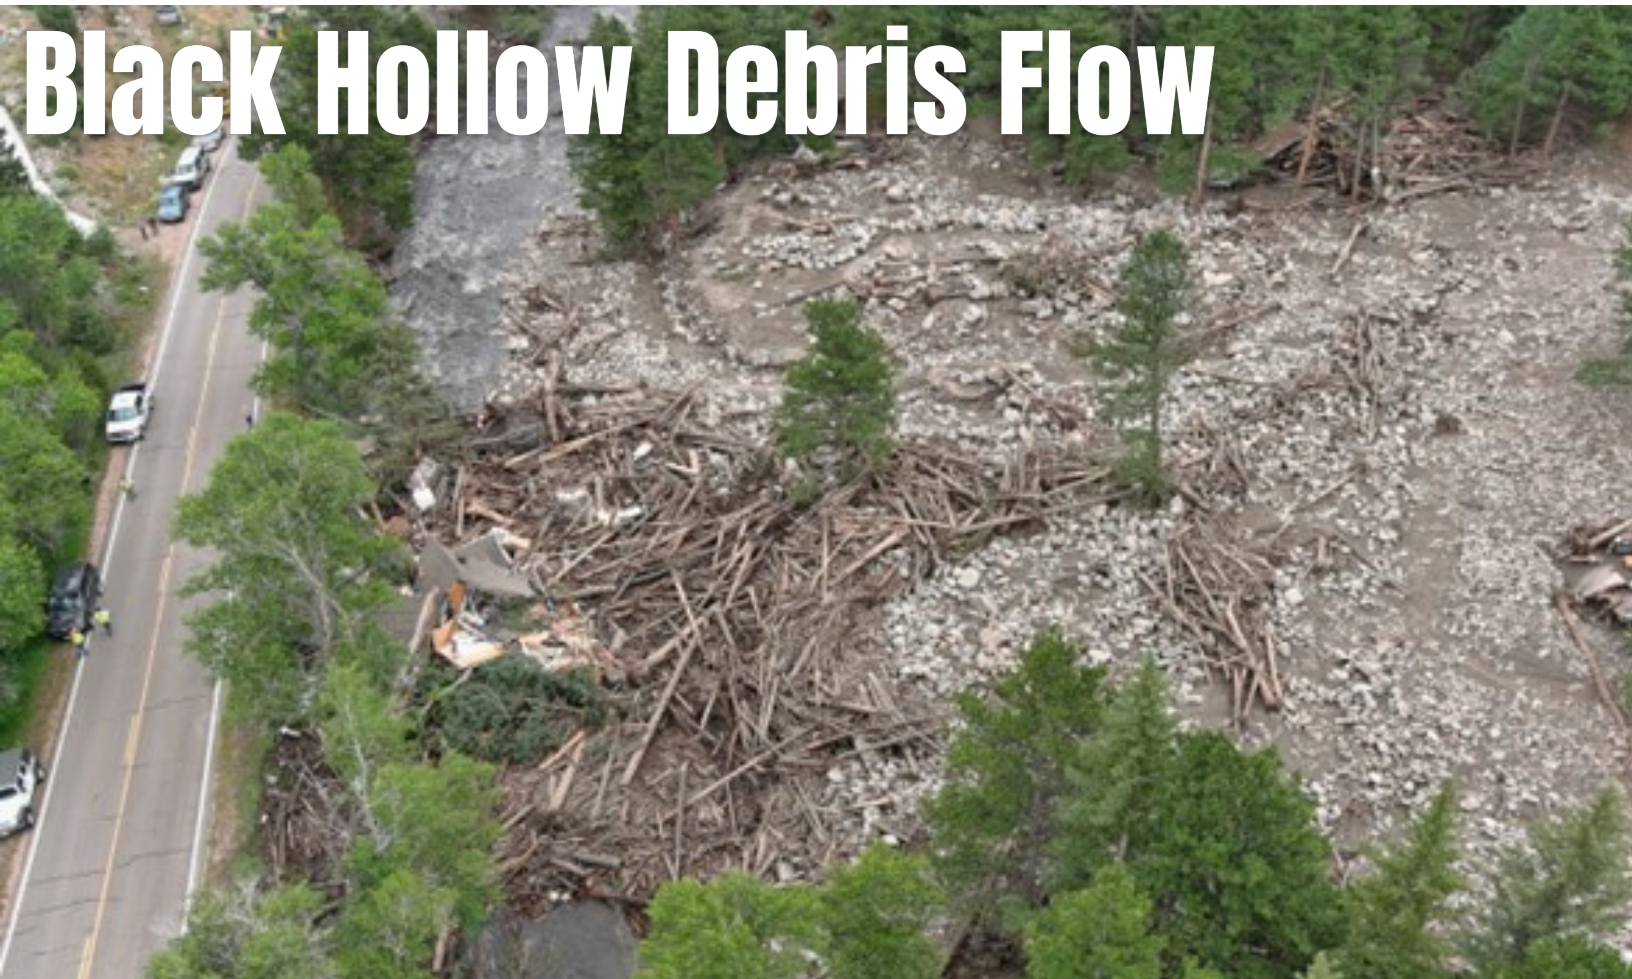
Black Hollow Debris Flow

A rainstorm on July 20, 2021 caused a large debris flow in the Black Hollow watershed. Six homes were destroyed and 4 people were killed in the event. The field trip group viewed the Black Hollow watershed at the top of the watershed and at the bottom of the watershed where it enters the Poudre River.

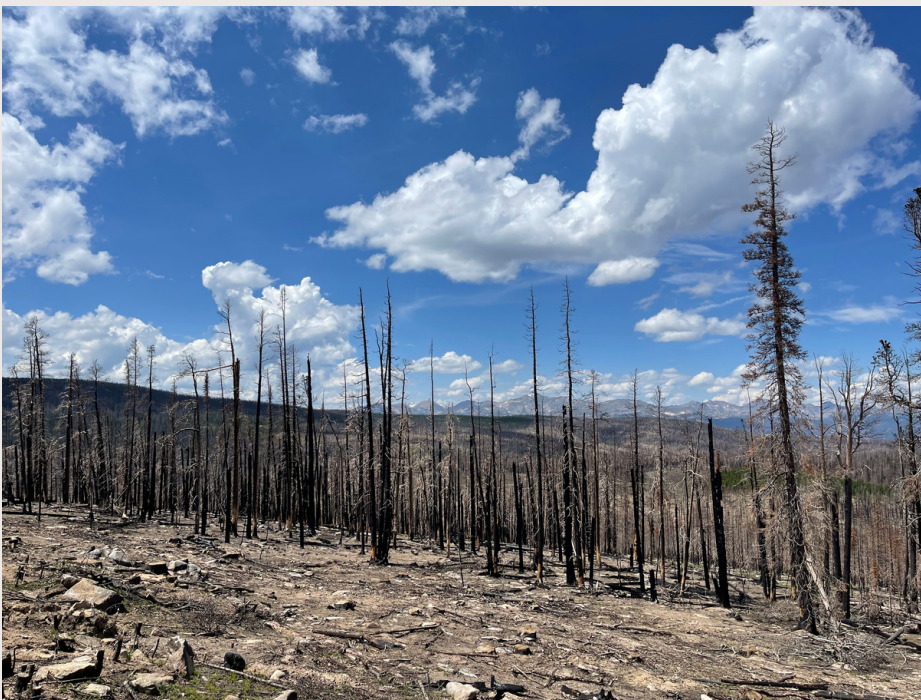
Head of Black Hollow drainage system, where 1/5 inch of rain fell in 1/2 hour causing major damage downstream.

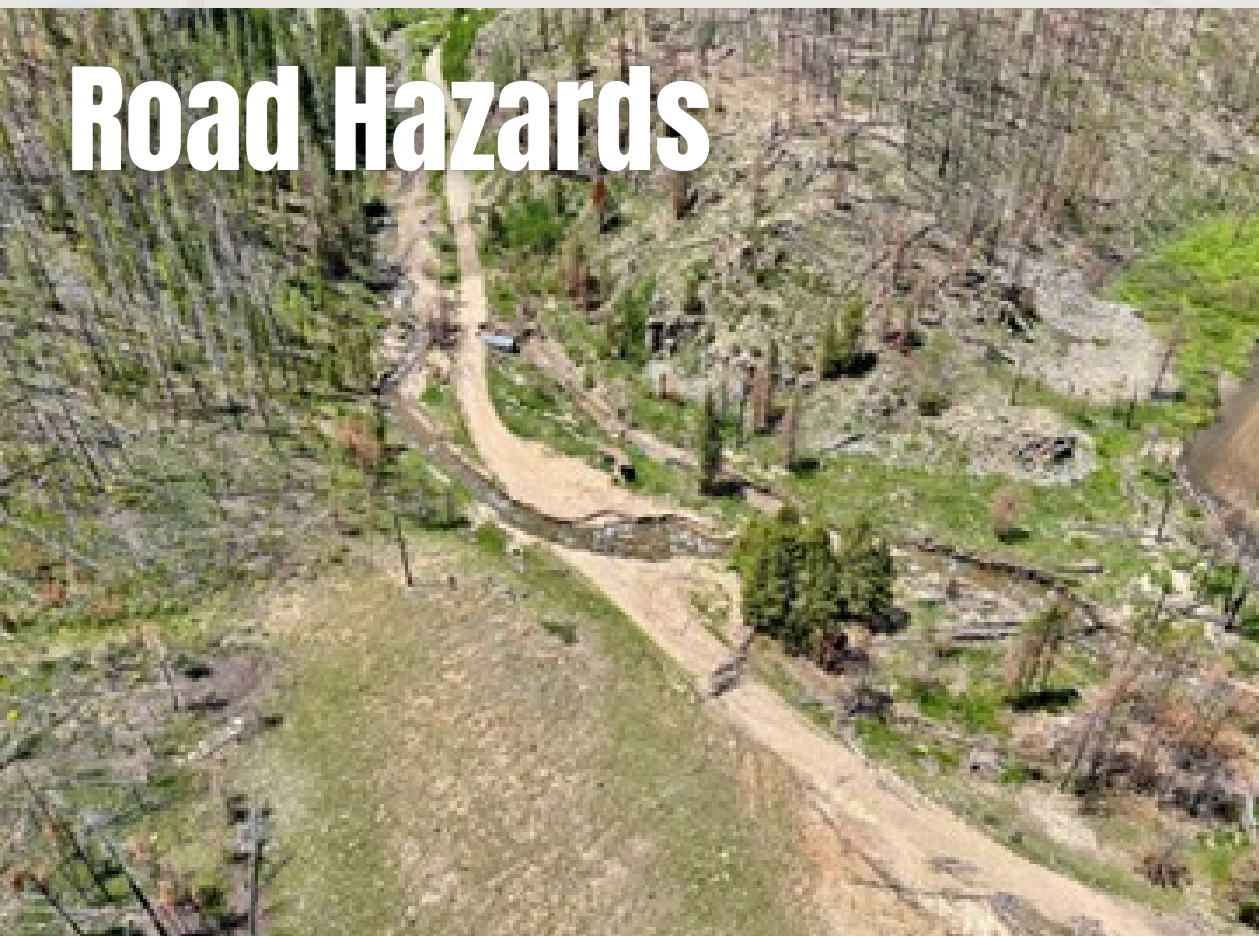
Roads can present hazards in post-fire conditions. The photo shows the Cabin Creek road crossing in the East Troublesome Fire.

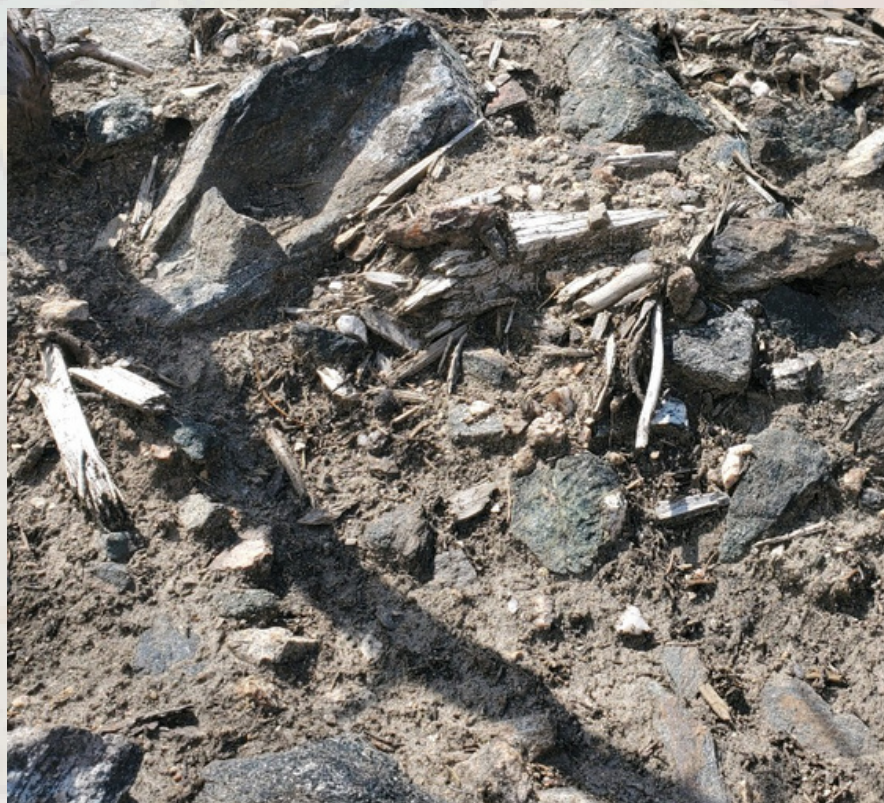
Close up of the landscape after an aerial mulching in a high priority area for future debris flows.
